2014 Geotechnical Annual Review, Minto Mine, YT

Minto Explorations Ltd.

SRK Consulting (Canada) Inc.
1CM002.028
November 2014

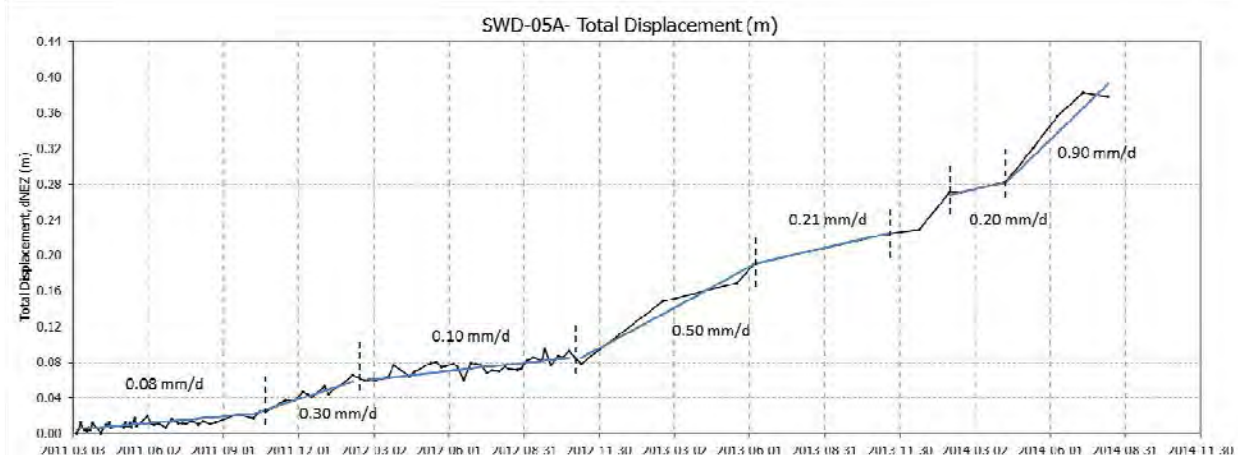
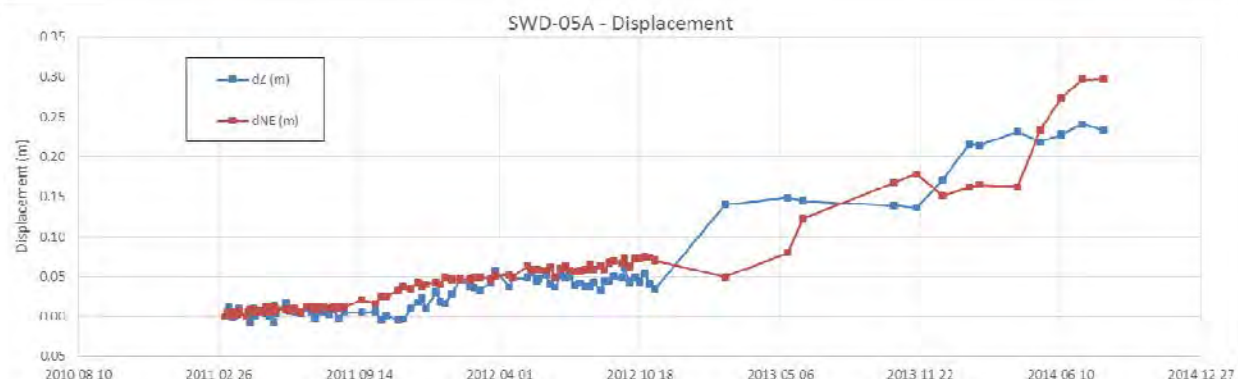
View of SWD-05A; heaved 30 cm out of the ground.

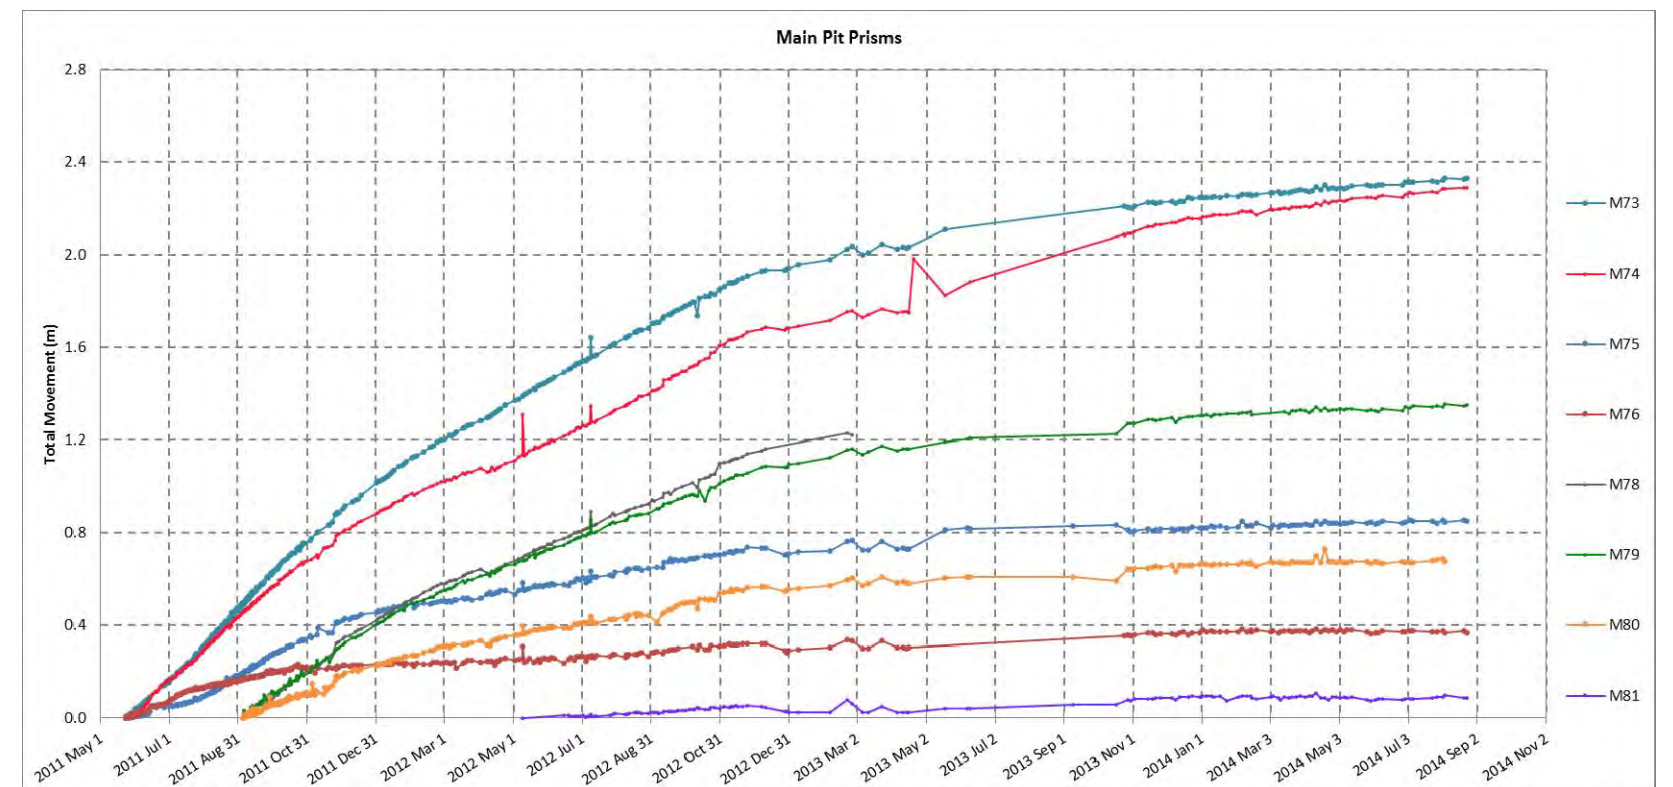
Survey Hub	Current Rate of Movement, dNEZ (mm/day)	Inspection Comment
M73	0.3	
M74	0.5	Heaved approx. 30cm above ground, and leaning towards the pit by ~20cm.
M75	0.1	
M76	no movement	
M79	0.1	Not Inspected.
M80	no movement	Not Inspected.
M81	no movement	Not Inspected.
