## **EAGLE GOLD HEAP LEACH FACILITY AND CYANIDE MANAGEMENT REVIEW**

**ENERGY, MINES & RESOURCES, YUKON GOVERNMENT**

JULY 2022

PROJECT 4667

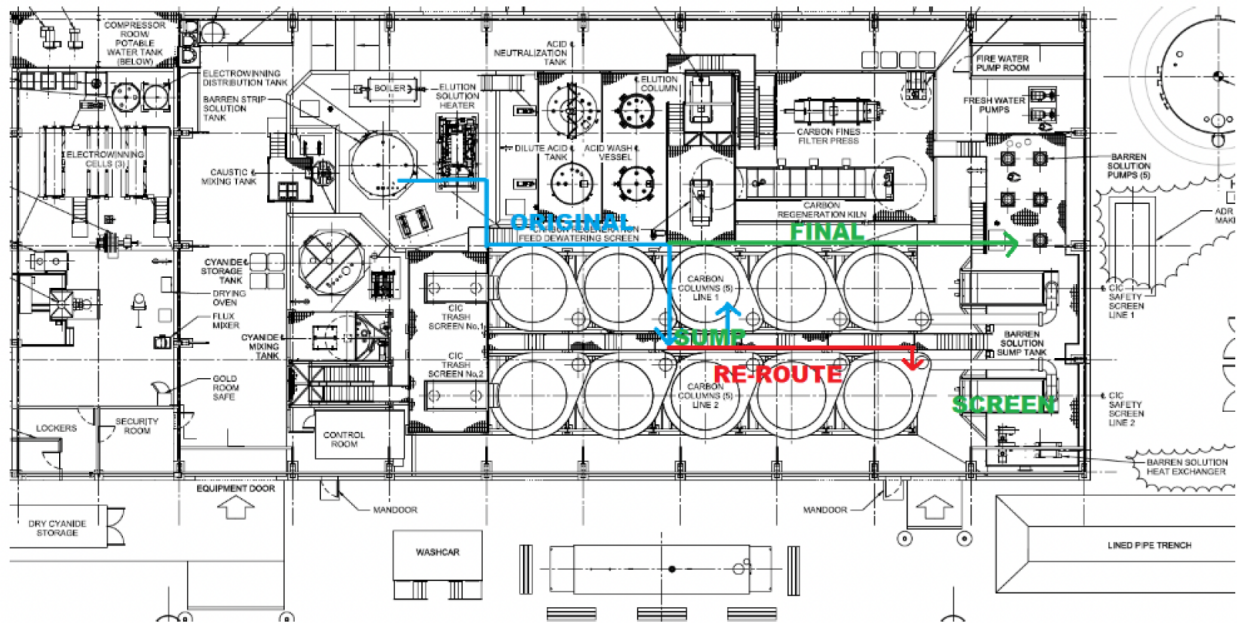
Figure 4-1: ADR Infrastructure Layout

There was a process solution release from the ADR plant on 22 June 2021 (Eagle Gold Project Spill Report, July 2, 2021). This was the third reported spill but the first related directly to the ADR plant. The Root Cause analysis presented in that report identified as the primary root cause *"a change in the routing of process solution, which enabled the introduction of warm caustic barren strip to the tail end of the south CIC train."* This, in turn, contributed to the formation of precipitate which blinded the fine discharge screens and allowed process solution to overflow onto the ADR plant floor and, ultimately, exit the plant through the ADR southeast bay door (see Photo 1, below, which is an excerpt of Photo 2-1 of the referenced spill report). Figure 4-1, also from that spill report (reproduced below), shows the original and re-routed flows.

Since moving pipes and clogged screens are common in ADR plants, this does not seem to address the actual root cause. The area where the spill occurred was within the ADR plant, but the containment was inadequate to hold this spill. This is in contrast with Section 4.1 of the Forte report (page 14) which states “Any spillage within the ADR plant are contained within the process plant containment.” Since any part of an ADR plant can be exposed to process solution the primary root cause is the lack of adequate containment, which was missed in the audit.

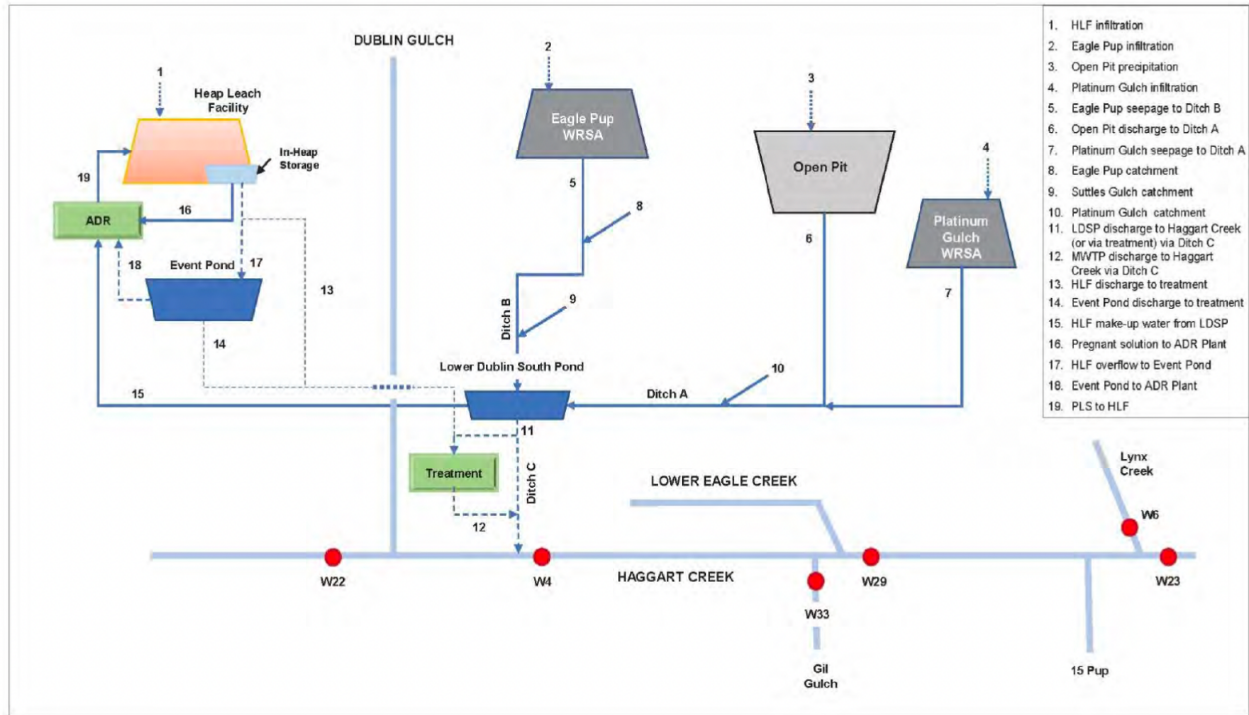
Figure 5.3-1: Site Water Balance Model

The water balance model is the subject of a separate technical memo, but since water balance management is discussed in the CMP (Section 5.3), some specific related issues are pointed out here. This section includes a schematic of the model as Figure 5.3-1, reproduced below. However, there is an important connection missing: water from the Lower Dublin South Pond (LDSP) is periodically pumped to the Events Pond (EP) to avoid discharging non-compliant water from the LDSP. Surplus surface water thus accumulated in the EP is occasionally discharged from the process circuit without treatment (i.e. #14 of Fig. 5.3-1, but not to treatment). Neither of these flows are reflected in the water balance model and that has contributed to extended periods of infringement on the Desired Available Storage (DAS) in the Events Pond during 2020 and 2021. A minor issue is that the diagram identifies the flow from the ADR to the HLF (#19 of Fig. 5.3-1) as "PLS to HLF." This is not usually PLS but rather barren solution.

The transfer of solution from the LDSP to the EP is contrary to the language of CMP Section 5.4.1 Prevention Measures for Open Ponds, which states "*The Events Pond will be maintained empty except to contain and temporarily store exceptional rainfall events or overflows from the in-heap pond.*" However, such exclusiveness in terms of use of EP is in the context of protecting wildlife, and so long as the EP has never been used to store process solution the risk to wildlife from these transfers should be minor.

2.3a: Update Sections 5.3 and 5.4 of the CMP, including Figure 5.3-1, to reflect the current water management system, including flows directed from the LDSP to the EP and discharges from the EP. This should occur with the next CMP update.
