Subject: 2022 Annual Geotechnical Inspection – Mining Related Earth Structures – Revision 1

2022 Annual Geotechnical Inspection Mining Related Earth Structures

Revision 1

JANUARY 3, 2023 ISSUED FOR USE FILE: 704-ENG.WARC04286-01

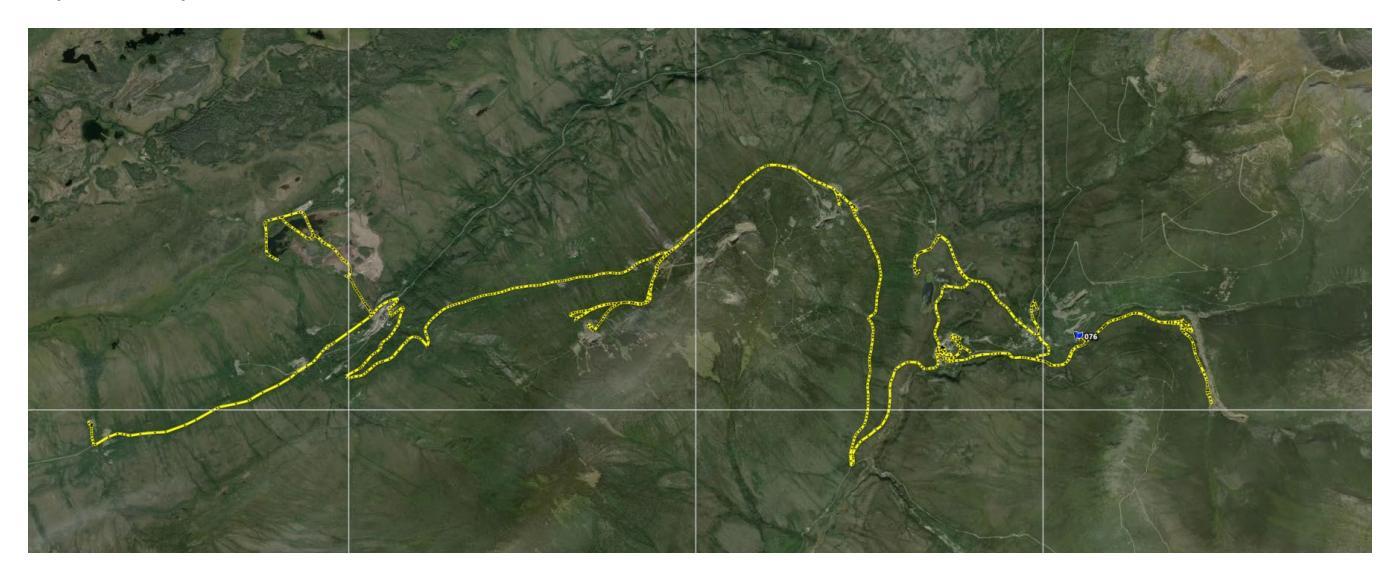
Figure 1: GPS tracklog of Mr. MacIntyre on August 28, 2022.

Figure 1 below shows a track collected by a GPS worn by Mr. MacIntyre. Note there were areas visited under separate scopes of work.
