| From: | Kai Woloshyn <kwoloshyn@alexcoresource.com></kwoloshyn@alexcoresource.com> |
|---|---|
| Subject: | FW: Annual geotech inspection |

October 27, 2016

Alexco Resource Corp. 3 – 151 Industrial Road Whitehorse, YT Y1A 2V3 ISSUED FOR USE FILE: ENG.WARC03152-01 Via Email: kwoloshyn@alexcoresource.com

Subject: 2016 Annual Geotechnical Inspection – Surface Engineered Earth Structures Bellekeno Mine, Keno City, YT

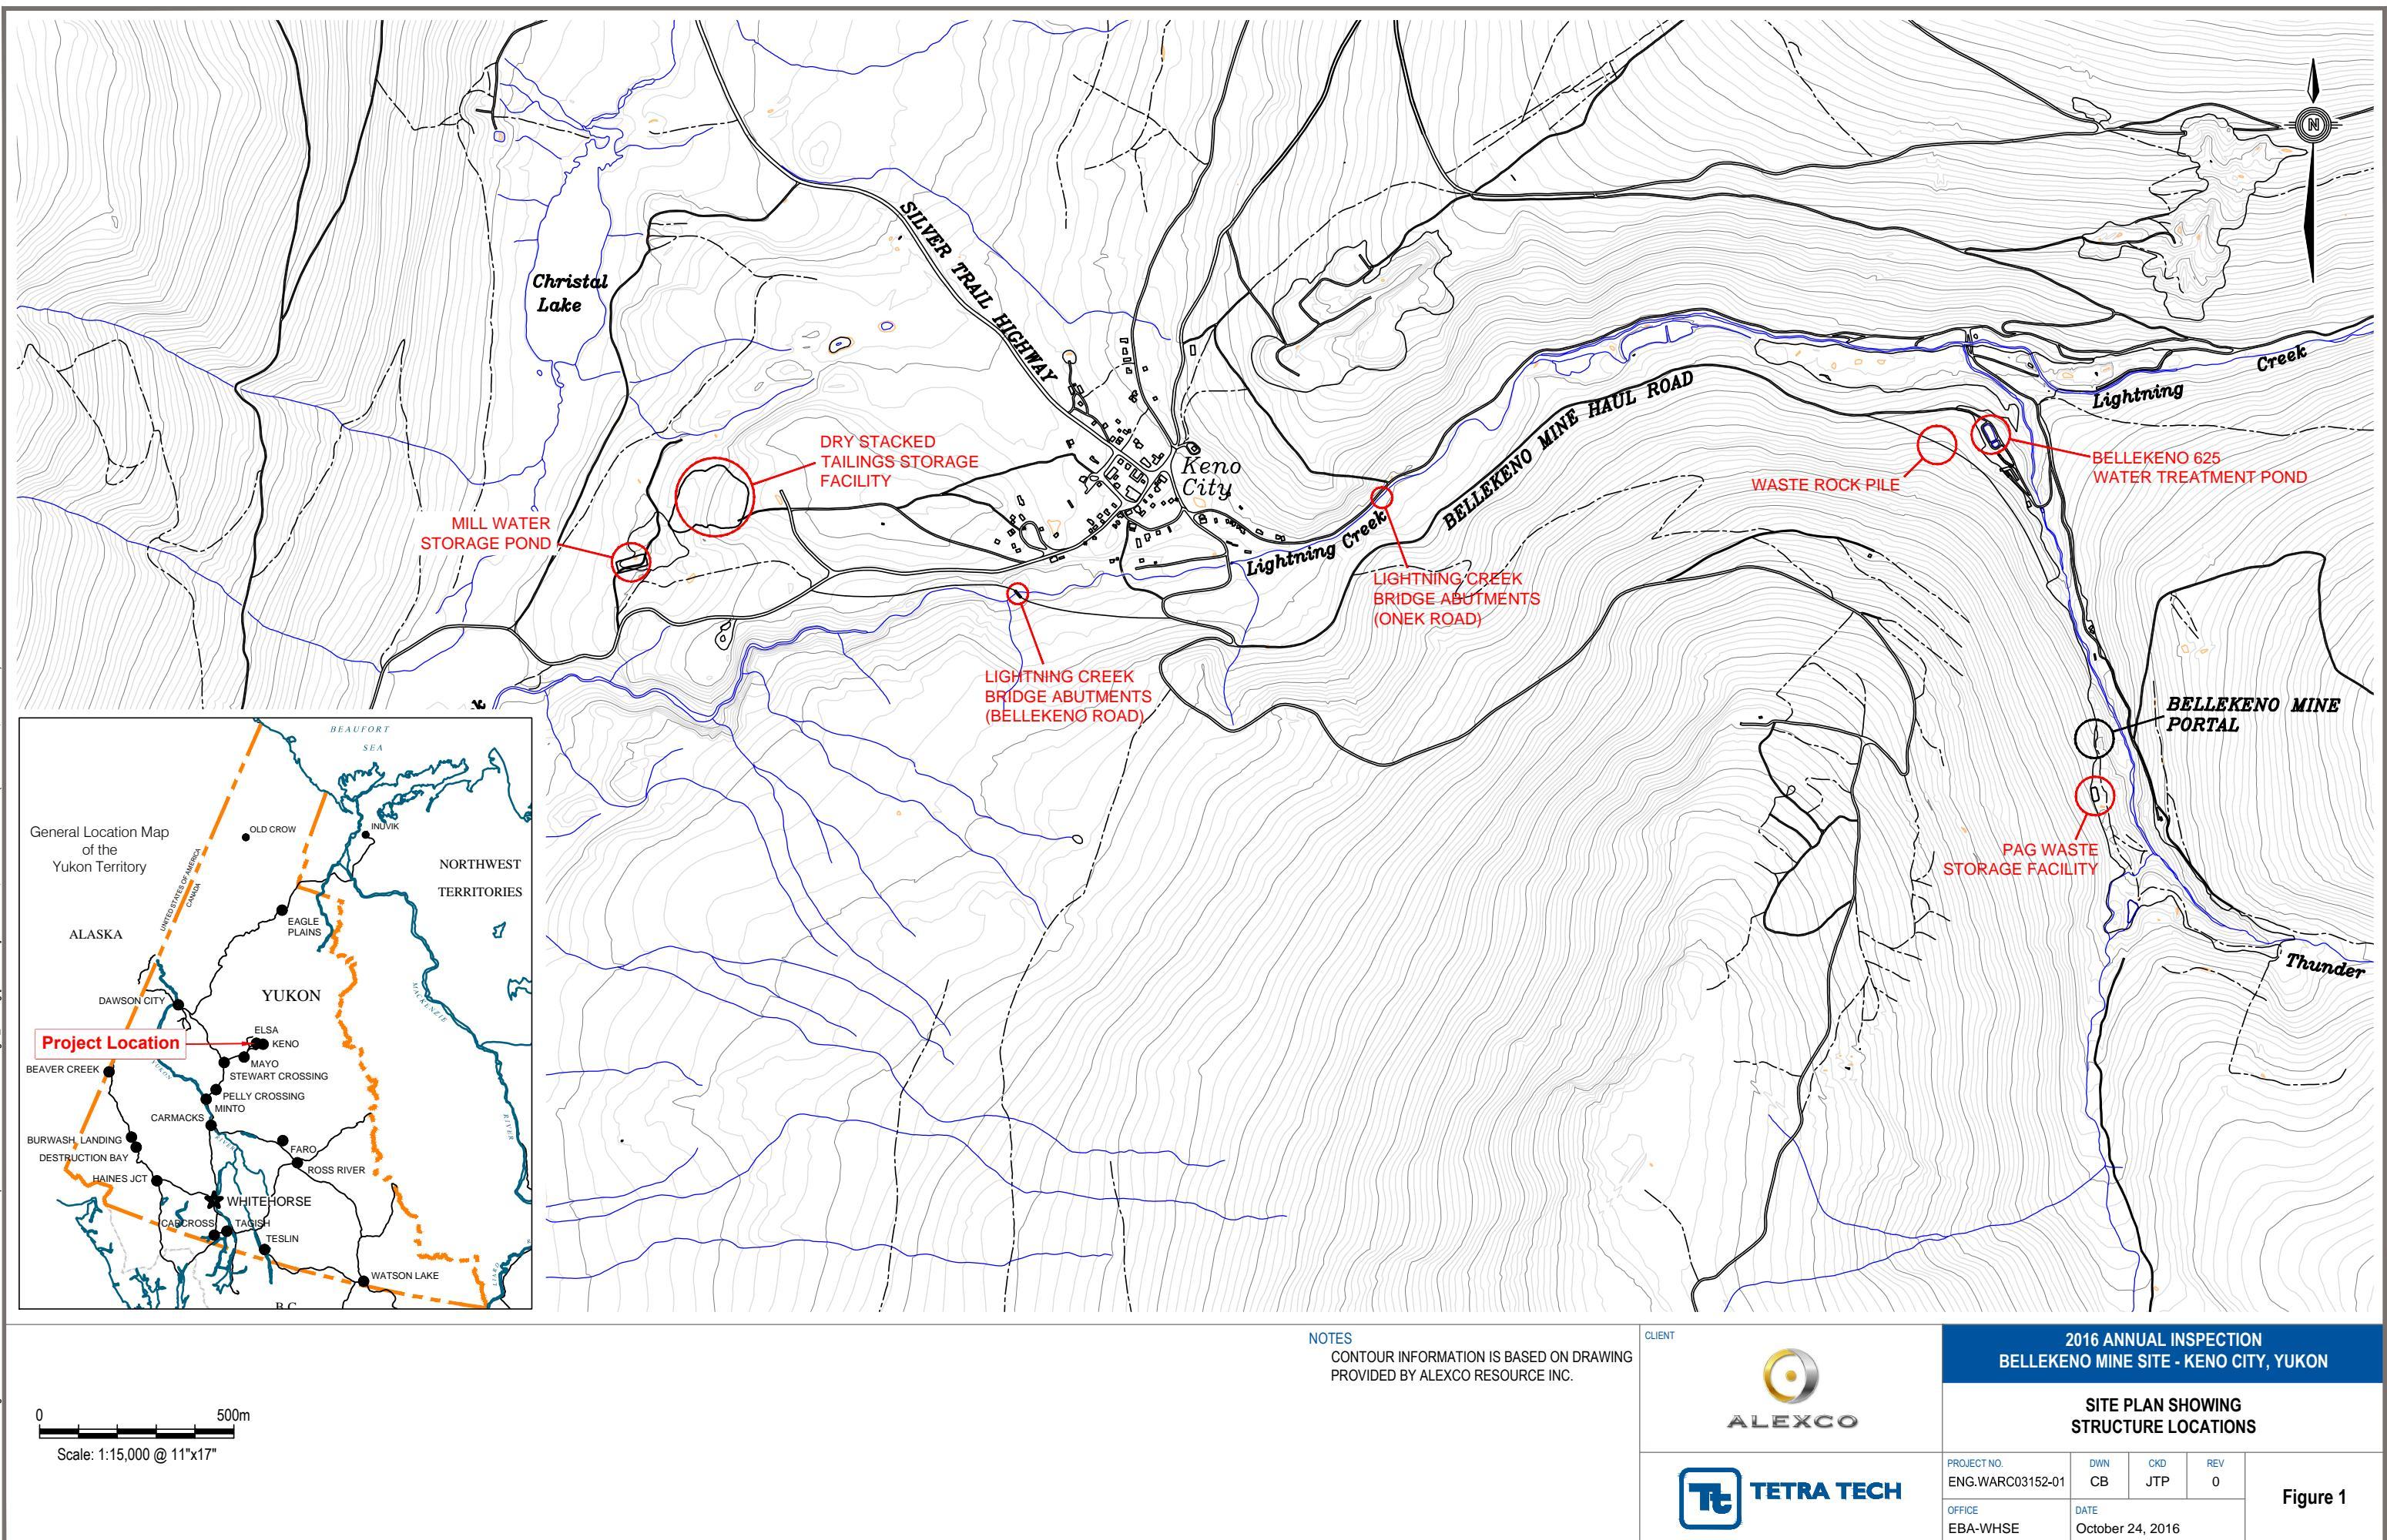
| PROJECT NO. | DWN | CKD | REV | |
|---|---|---|---|---|
| | | | | Figure 1 |

The location of each structure is shown on Figure 1.
