2016 Geotechnical Inspection Tailings Management Facility Sä Dena Hes, Yukon Territory

Teck Resources Limited

SRK Consulting (Canada) Inc.
1CT008.057
October 2016

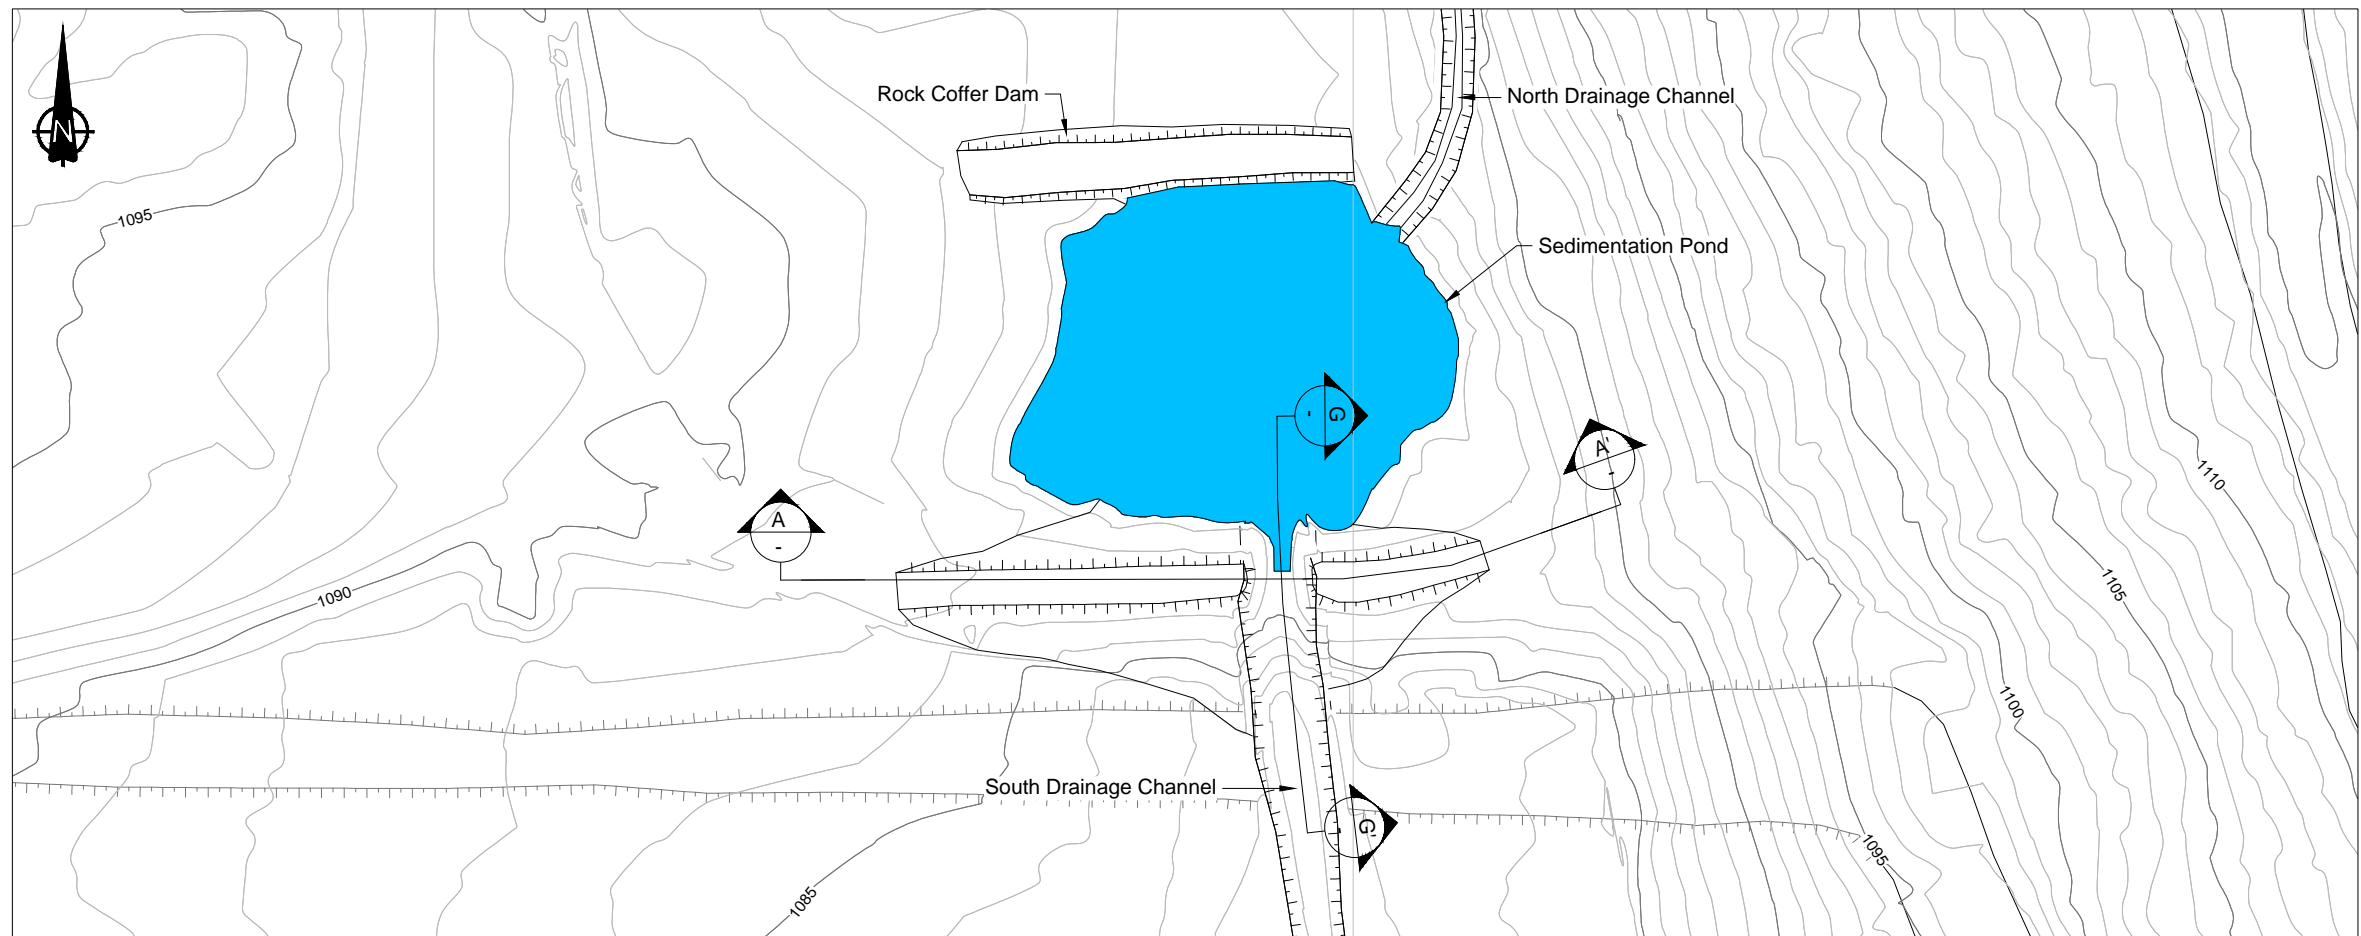
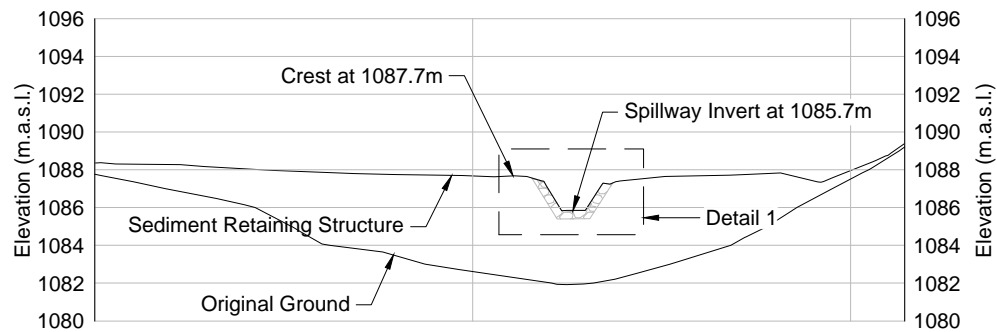
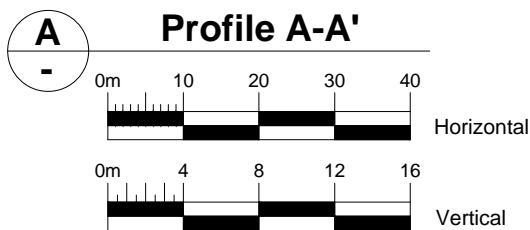
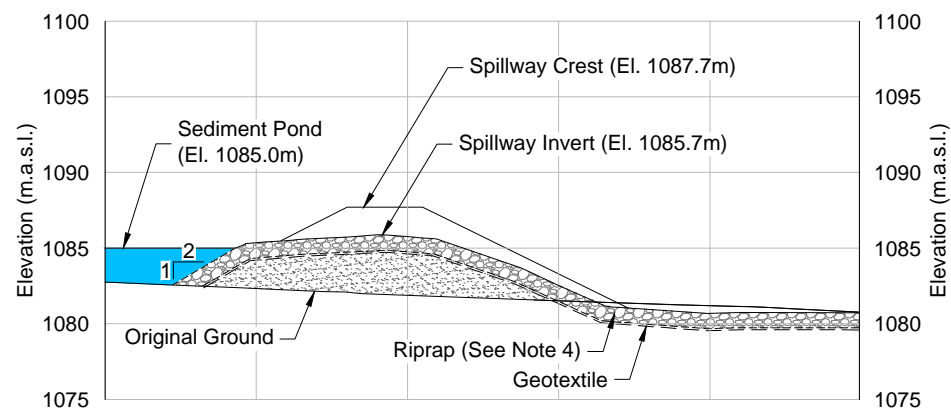
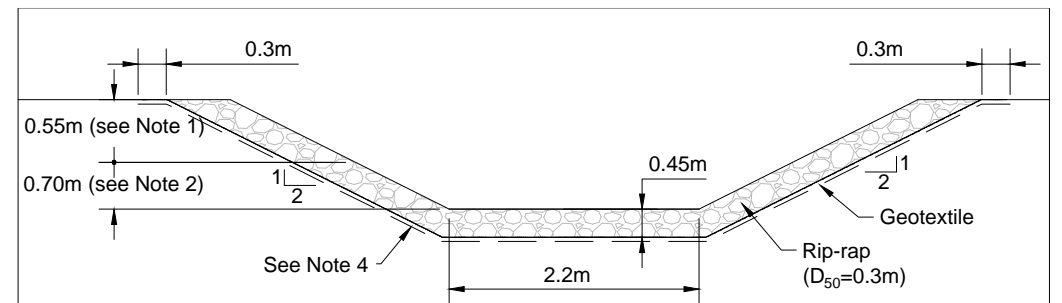
DATE: September 2016
APPROVED: PMH
DRAWING: 6

During the 2015 inspection, a small subsidence was observed in the lower portion of the exit chute from the spillway. The material displaced was retained by the geotextile filter fabric and some of the riprap had moved. Teck repaired the spillway after the 2015 inspection by placing additional riprap from the cofferdam located upstream of the pond. No further subsidence was noted during this year's inspection.

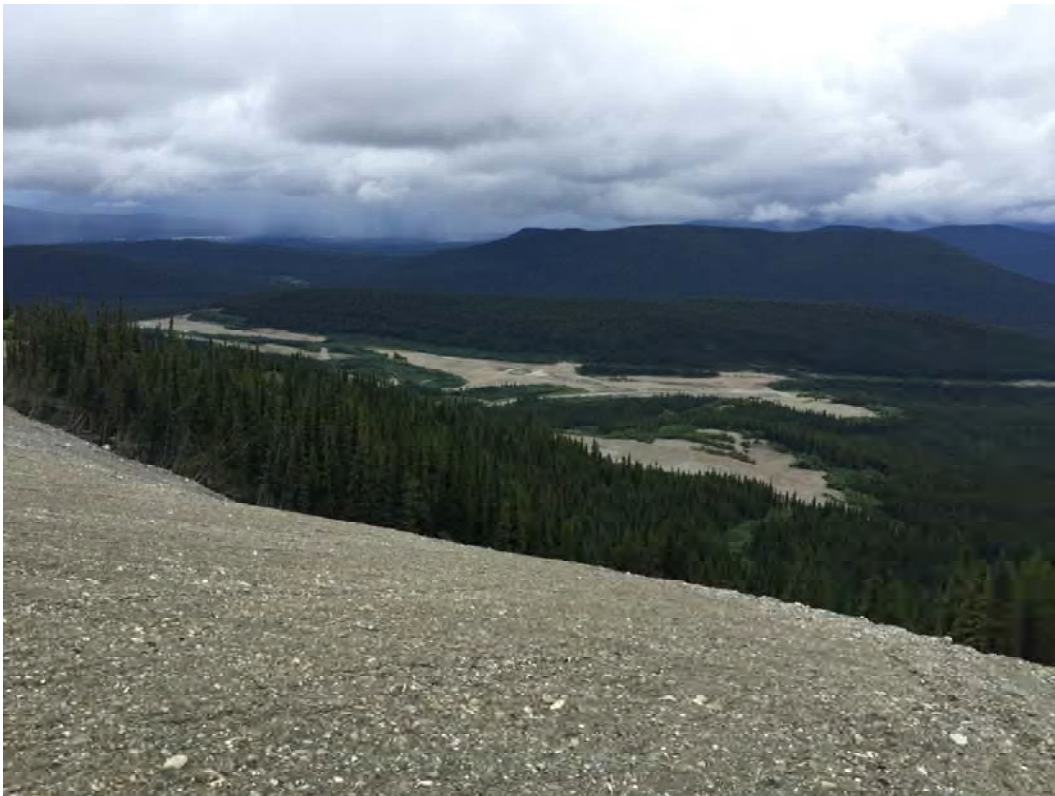
Photo 24 was taken from the Jewelbox dump overlooking the TMA.

Photo 24: Overview of the TMA from Jewelbox Dump
