SÄ DENA HES OPERATING CORPORATION

SÄ DENA HES MINE

DETAILED DECOMMISSIONING & RECLAMATION

AUGUST 2015 UPDATE

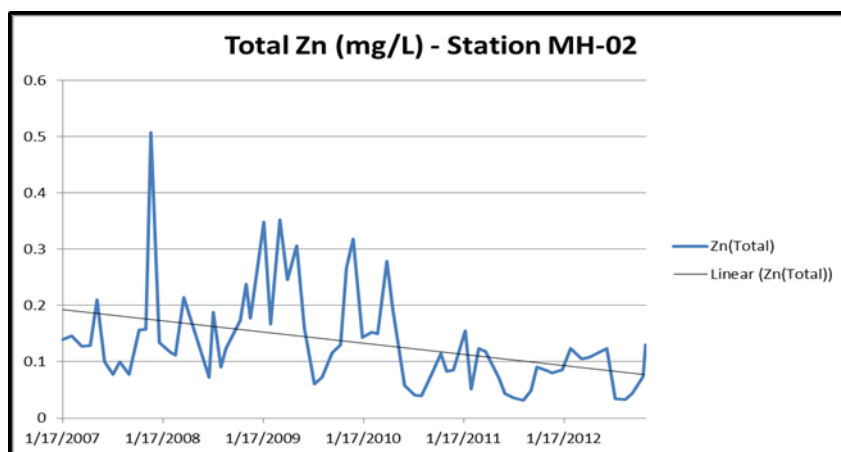
A short term increase in total zinc levels at MH-02 in 2009 was noted in the 2010 update, however further data collected to the end of 2011 and 2012 continues to show a decreasing trend. The following graph shows that zinc concentrations appear to increase over periods of low flows i.e., winter, however there is a definite downward trend still continuing. Significant higher total suspended solids readings associated with the elevated zinc levels suggest that the high readings are likely the result of sampling problems (i.e. sediments collected accidentally in water samples due to the low creek levels).

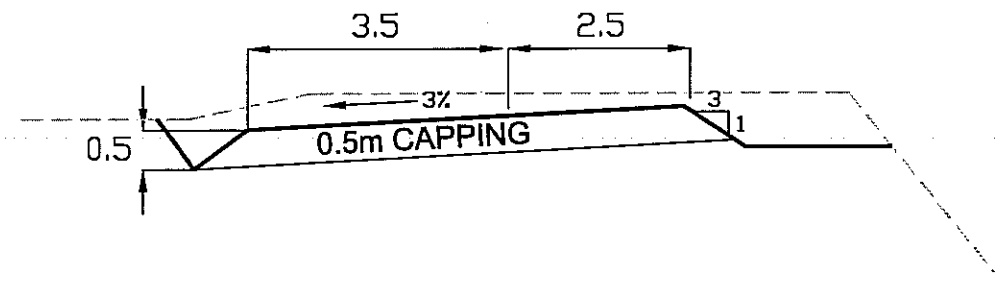
TYPICAL SECTION SINGLE LANE WITHOUT BERM

Sta. 0+000 to 2+413

ALL SIDE SLOPES 1.5:1 EXCEPT WHERE NOTED
AND DITCH SLOPE OF 3:1

H= 1:200 V= 1:100

A network of service and haul roads exist on the property (Figure 3-1). These roads provided access to the mine workings, tailings management facilities, and site infrastructure. Figure 3-12 (Typical Section Haul Road) provides a typical section through a haul road, with and without safety berms.

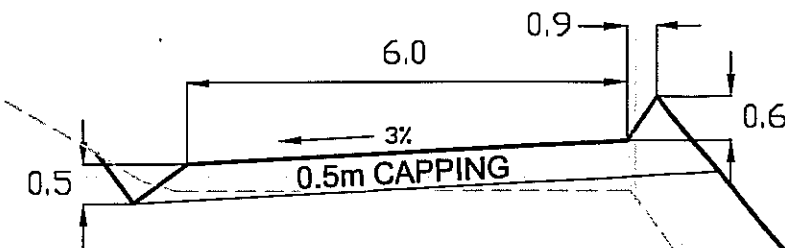
TYPICAL SECTION SINGLE LANE WITH BERM

Sta. 0+000 to 1+400

ALL SIDE SLOPES 1.5:1 EXCEPT WHERE NOTED
AND DITCH SLOPE OF 3:1

H= 1:200 V= 1:100

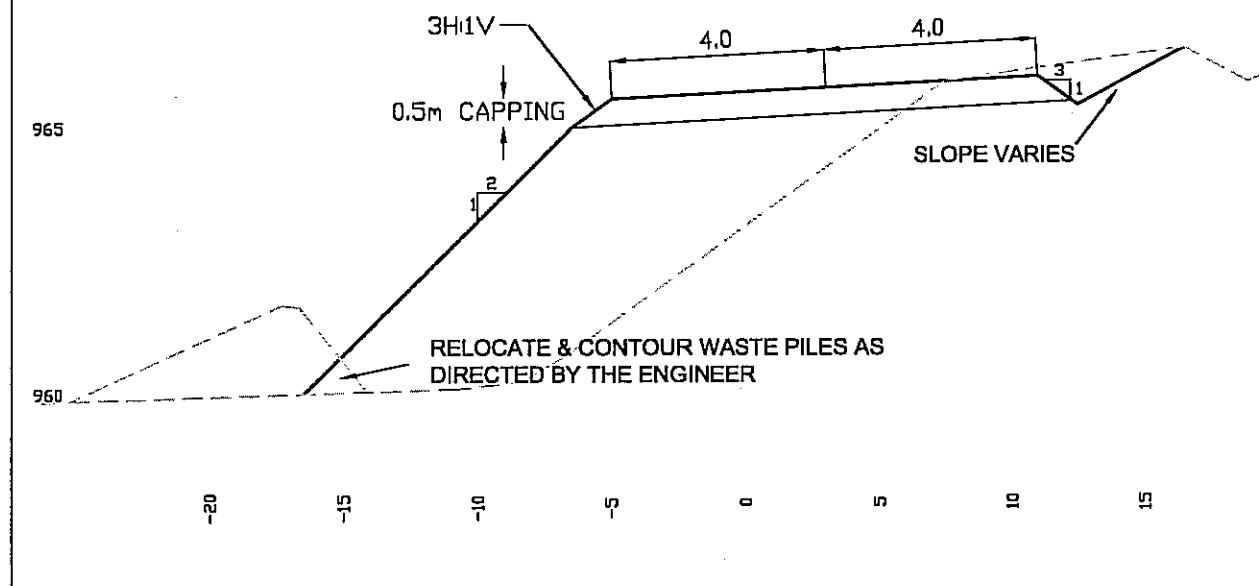
Fig No. 3-12

TYPICAL CROSS SECTION

STATION 15+800
H= 1:400 V= 1:200

ACCESS ROAD - TYPICAL

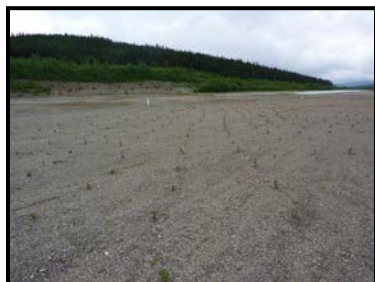
Alder test plots – 2010

Results to date indicate that uptake of metals in alder is much lower than in willow. As would be expected, metal uptake was greater in plants growing directly on the tailings as opposed to the plants growing on the capped portion of the tailings. During the first two seasons of growth there was little difference between the vigor of plants growing on till versus those growing directly on the tailings. However, observations conducted in 2012 showed that the plants growing on the till exhibit significantly increased vigor (plant height approximately 2 feet) and those growing directly on the tailings showed definite signs of stress. The following photos show the results of three years of growth.
