Rockland Ltd

Rock Engineering and Mine Backfill Specialist

Re: INSPECTION REPORT FOR QUARTZ MINING LICENSE - UNDERGROUND GEOTECHNICAL
INSPECTION

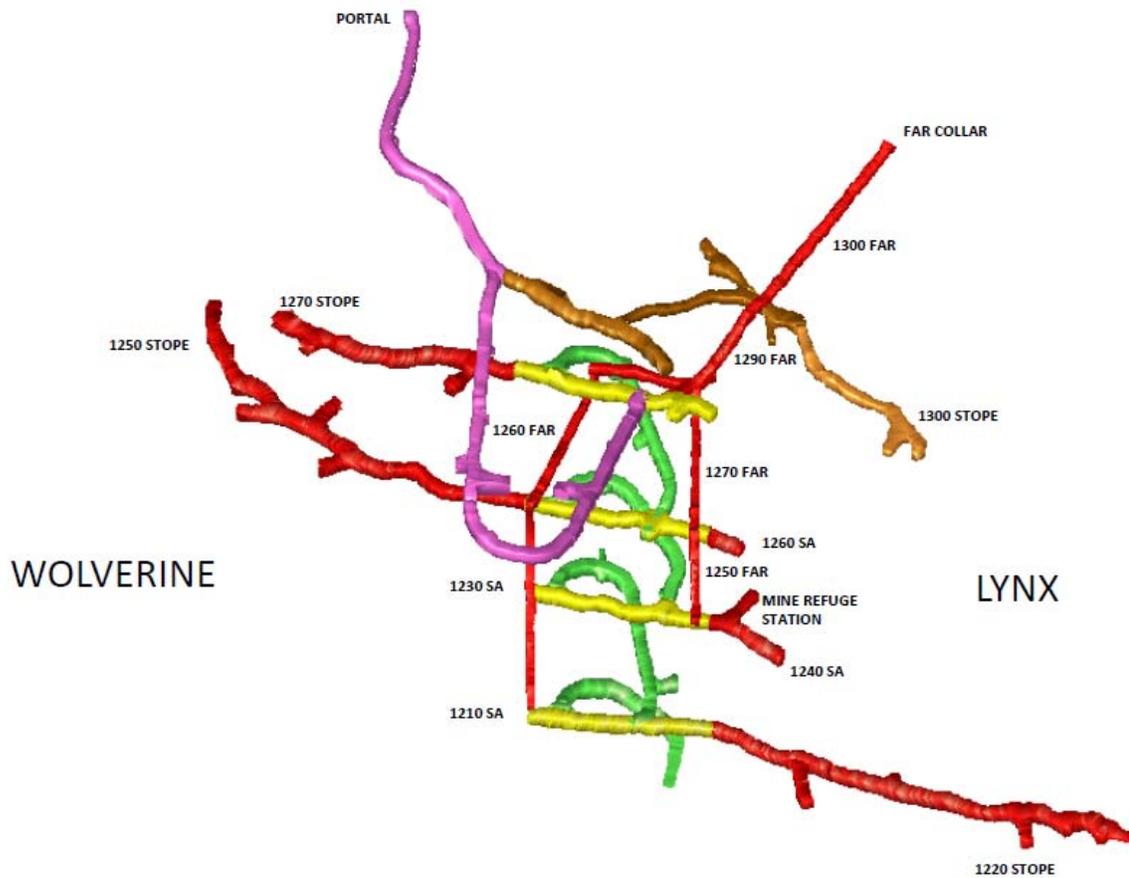
The inspection program consisted of several site visits to Wolverine. The current underground excavations, as shown in Figure 1, consist of a Ramp, several Stopes Accesses (SAs), Stopes and Fresh Air Raises (FARs).

Figure 1: Ramp, SAs, Stopes and FARs at Wolverine mine
