# Annual Quartz Mining License Report for 2023

Property: Sä Dena Hes Mine  
Company: Sä Dena Hes Operating Corporation  
c/o Teck Resources Limited  
Permit #: QML-0004

Effective Date: March 28, 2024

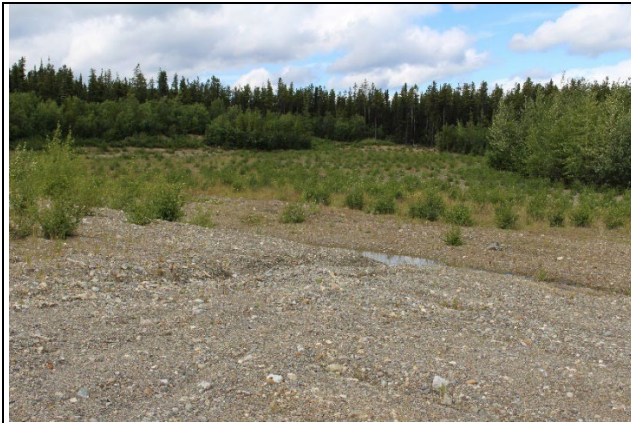
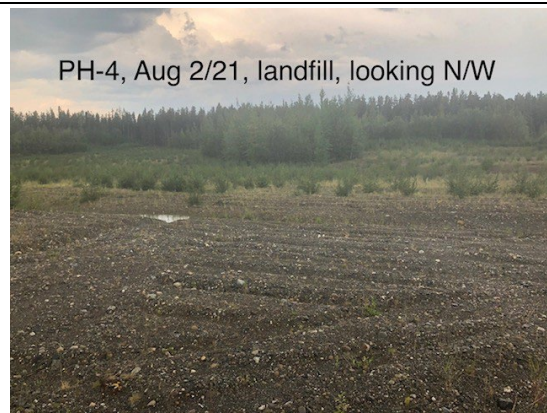
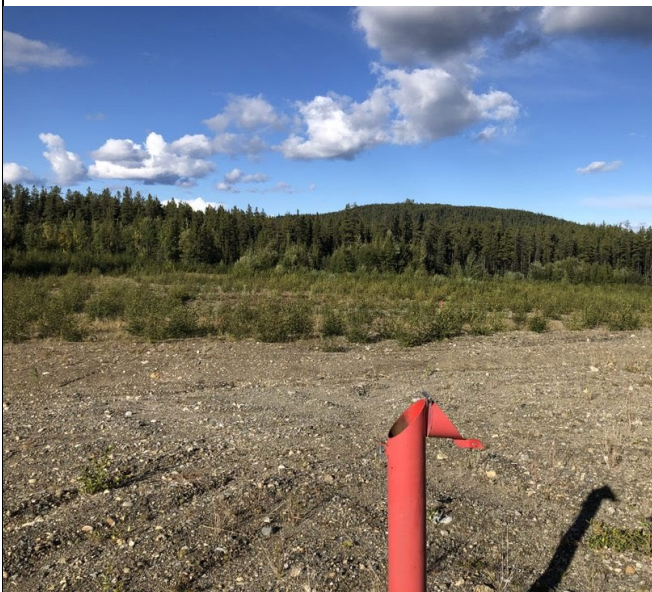
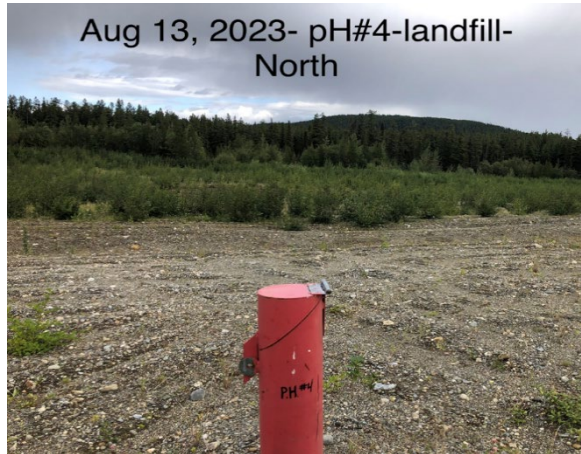
**A.5 Photo Hub 4 – Landfill at MW14-02 and VMP-9**

PH-4, Aug 2/21, landfill, looking N/W

Aug 13, 2023- pH#4-landfill-  
North
