Water Quality Objective Monitoring, White River Basin, 2013

Hydrologic and Geomorphic Characteristics of the White River Drainage Basin

Water Quality Objective monitoring, White River Watershed – Summary

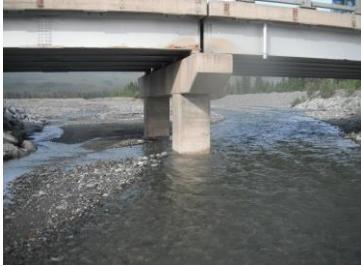
WH_DO_KL_BU01 JULY 17, 2013

Unfortunately, in 2013, as in past monitoring seasons, the Kluane drainage area once again proved very difficult to monitor with automated sampling equipment and data loggers. As one example of the problems that kept plaguing our efforts, Burwash Creek experienced extremely high flow variability and major channel migration. This is due in part to the heavy rain events recorded in the region on July 10th, 20th, 25th and 31st, which washed through the area, moved the channel in the creek bed from the left limit of the channel 10 meters to the east, right up against the right limit of the channel. This violent shift in the channel left our monitoring equipment out of the water and unable to automatically collect any sample. At the same time this shift in the channel and the scouring effect and then redeposit of bed material from one side to the other, buried our level monitoring equipment beneath 1-1.5 m of bed material, were it remains to this day.

In the future, a greater effort must be made to collect, on a more frequent base, manual grab samples. It is too difficult to maintain and keep operating automated sampling equipment in this type of dynamic environment. Highly variable flows and meandering streams in wide channels make it impossible to keep stationary sampling instrumentation in the water course.
