## Site Assessment Report – 2013 – YPS-090

Site	YPS-090
Sample Date	July 17 2013
Latitude	N 63.7694
Longitude	W 139.6300
Altitude	1200 ft
Feature Name	Indian River
Stream Order	6

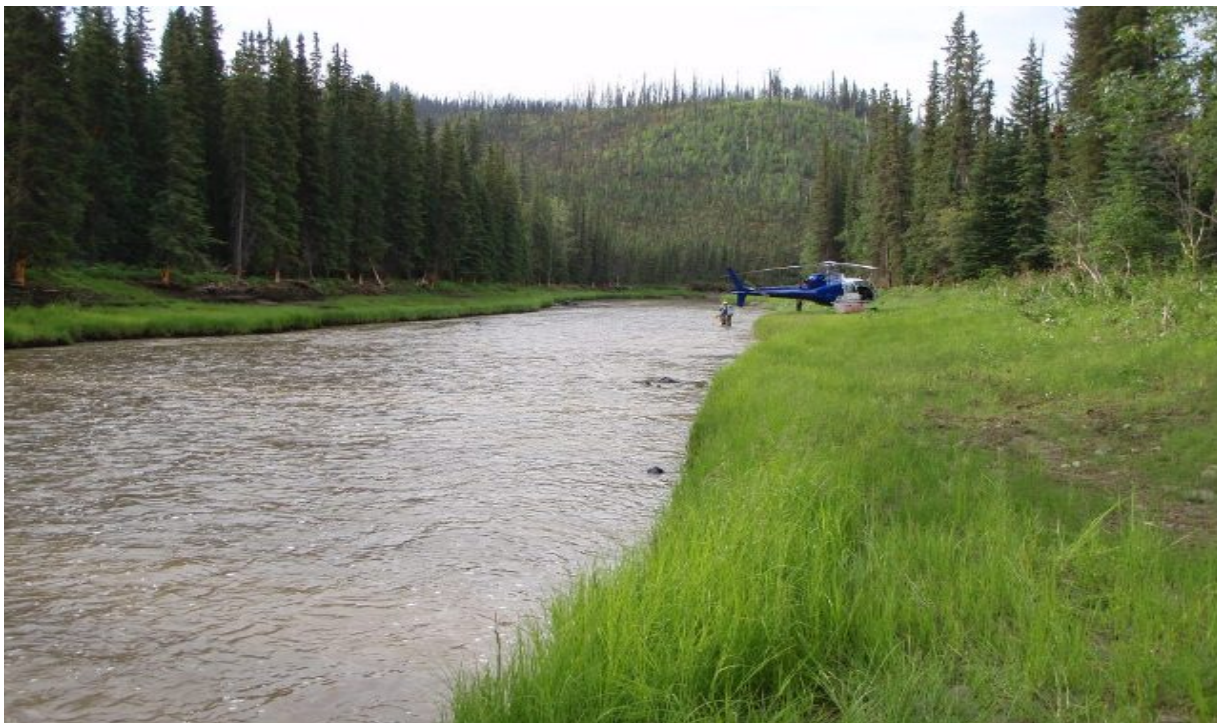
Downstream view
