Site Assessment Report – 2013 – YPS-096

Site	YPS-096
Sample Date	July 18 2013
Latitude	N 63.7580
Longitude	W 139.2452
Altitude	1378 ft
Feature Name	Indian River
Stream Order	6

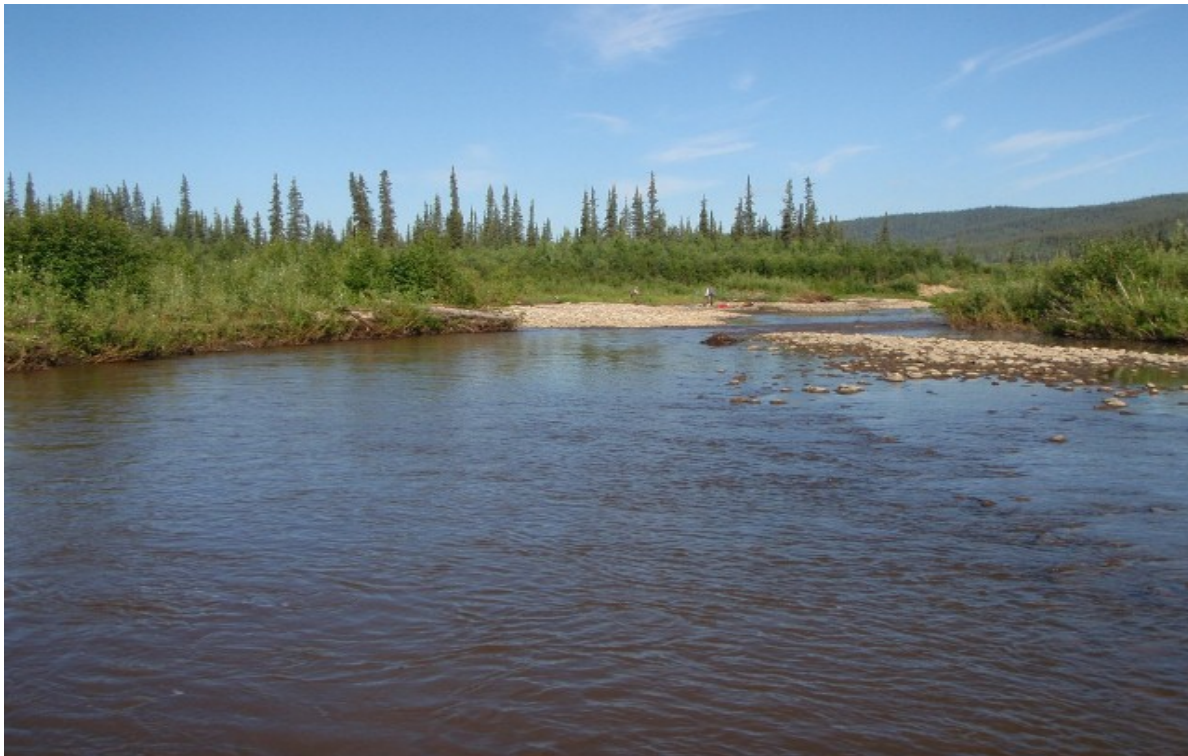
Site Photograph

Downstream view
