Site Assessment Report – 2013 – YPS-166

Site	YPS-166
Sample Date	August 6 2013
Latitude	N 63.6844
Longitude	W 137.0635
Altitude	1840 ft
Feature Name	Vancouver Creek
Stream Order	4

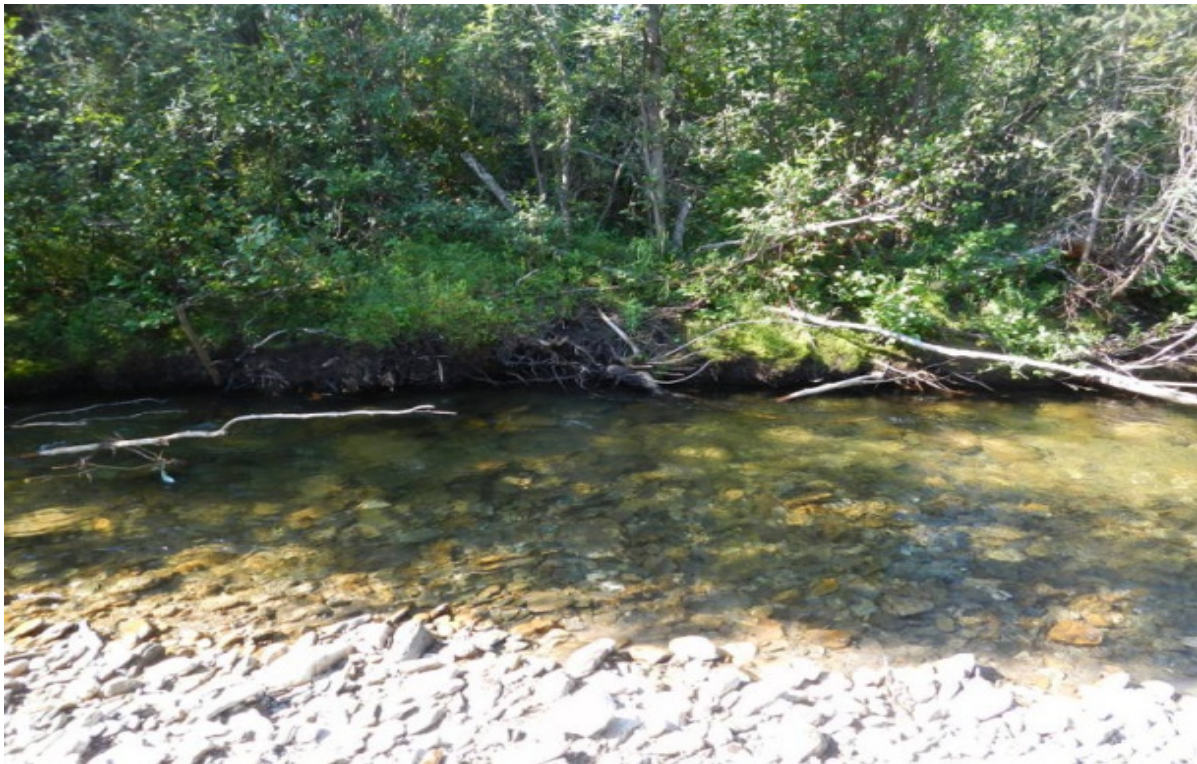
Site Photograph

Across channel view
