## Site Assessment Report – 2013 – YPS-428

Site	YPS-428
Sample Date	July 16 2013
Latitude	N 63.2550
Longitude	W 138.6900
Altitude	1248 ft
Feature Name	Black Hills Creek
Stream Order	4

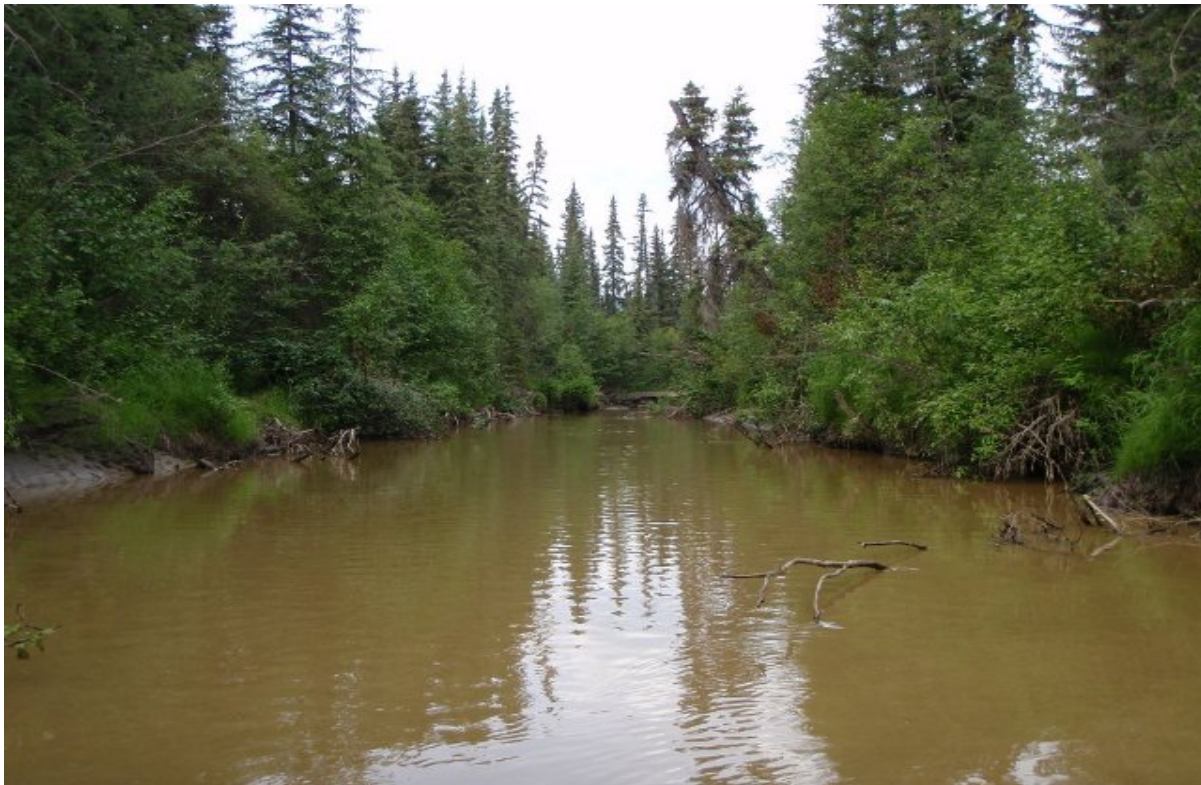
Upstream view
