## Site Assessment Report – 2013 – YPS- 565

Site	YPS- 565
Sample Date	Aug 1, 2013
Latitude	N 61.5254
Longitude	W 139.3159
Altitude	2414 ft
Feature Name	Quill Creek
Stream Order	4

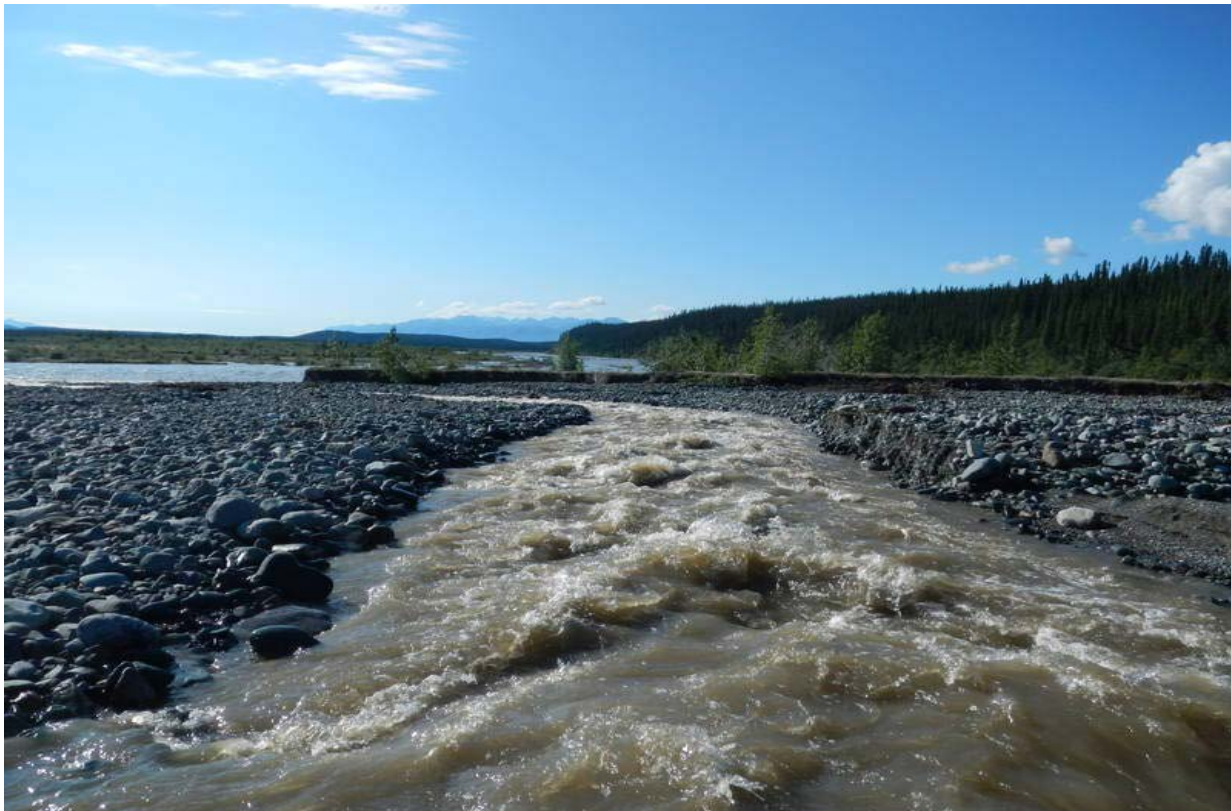
Downstream View
