## Site Assessment Report – 2013 – YPS- 569

Site	YPS- 569
Sample Date	Aug 7, 2013
Latitude	N 63.9357
Longitude	W 138.6285
Altitude	1558 ft
Feature Name	Allgold Creek
Stream Order	4

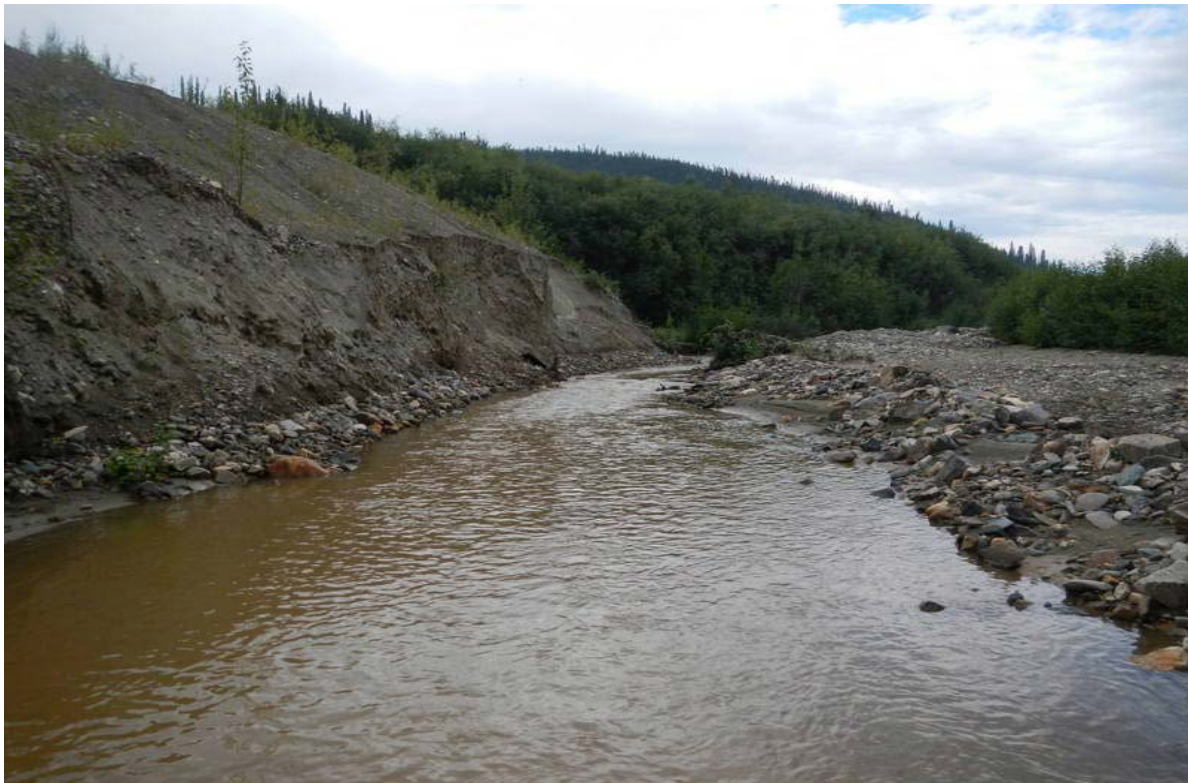
Upstream view

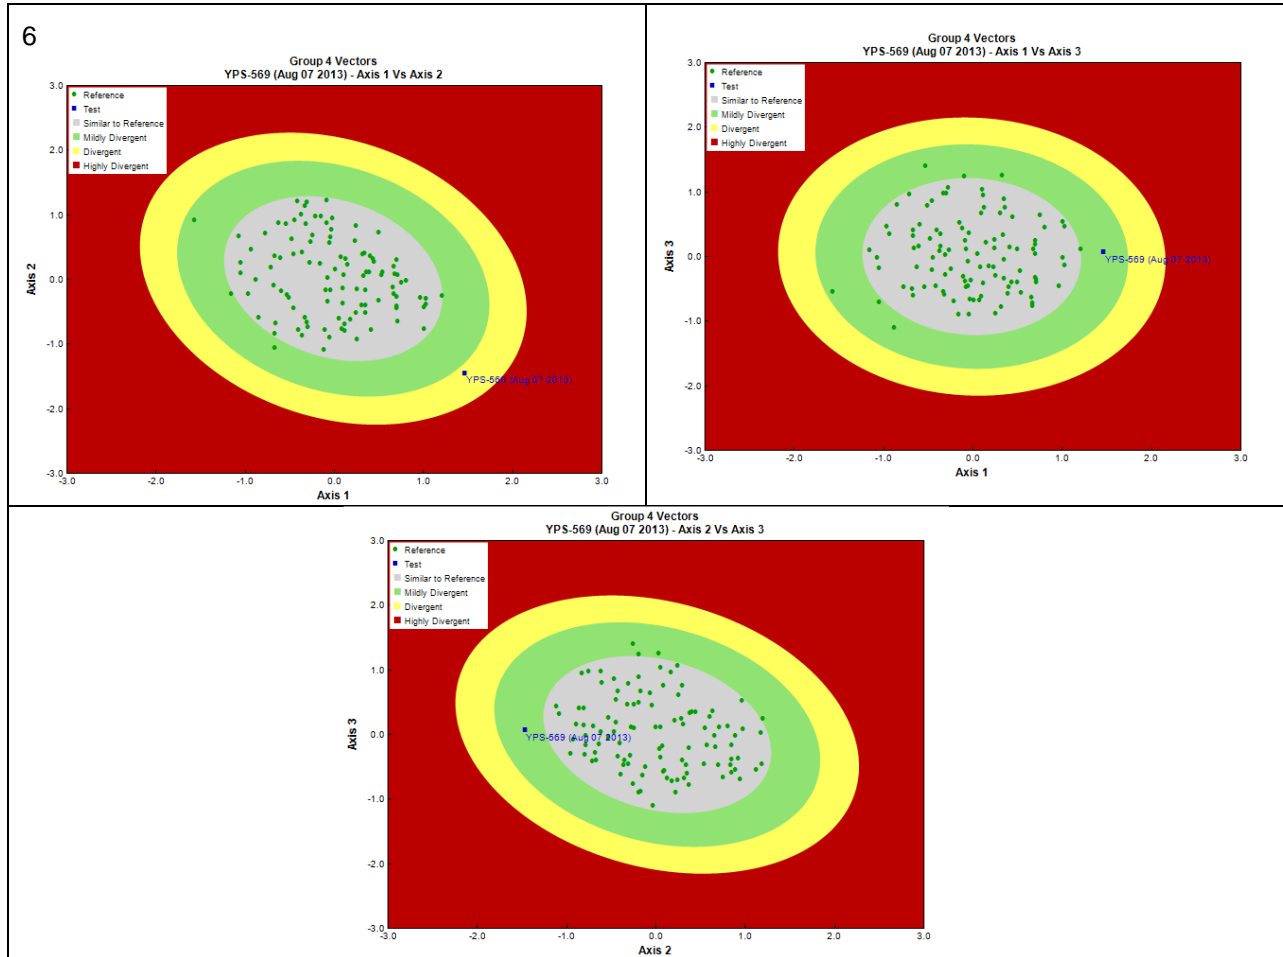
This figure displays three site assessment graphs which show the site relative to the group of reference sites to which it is compared. The three axes (or vectors) represent three dimensional space, and the probability bands (from center) are 75 - 90% (Similar to Reference), 90 – 99% (Mildly Divergent from Reference), 99 – 99.9% (Divergent from Reference), and outside 99.9% (Highly Divergent from Reference).

Vector 1 vs Vector 2	Divergent from Reference Condition
Vector 1 vs Vector 3	Mildly Divergent from Reference Condition
Vector 2 vs Vector 3	Mildly Divergent from Reference Condition
Overall	Divergent from Reference Condition

Using CABIN, YPS- 569 is assessed as Divergent from Reference Condition.
