Site Assessment Report 2014 – YPS-411

Site	YPS-411
Sample Date	Jul 24 2014
Latitude	62.34793 N
Longitude	137.30255 W
Altitude	2700
Feature Name	Mechanic Creek
Stream Order	2

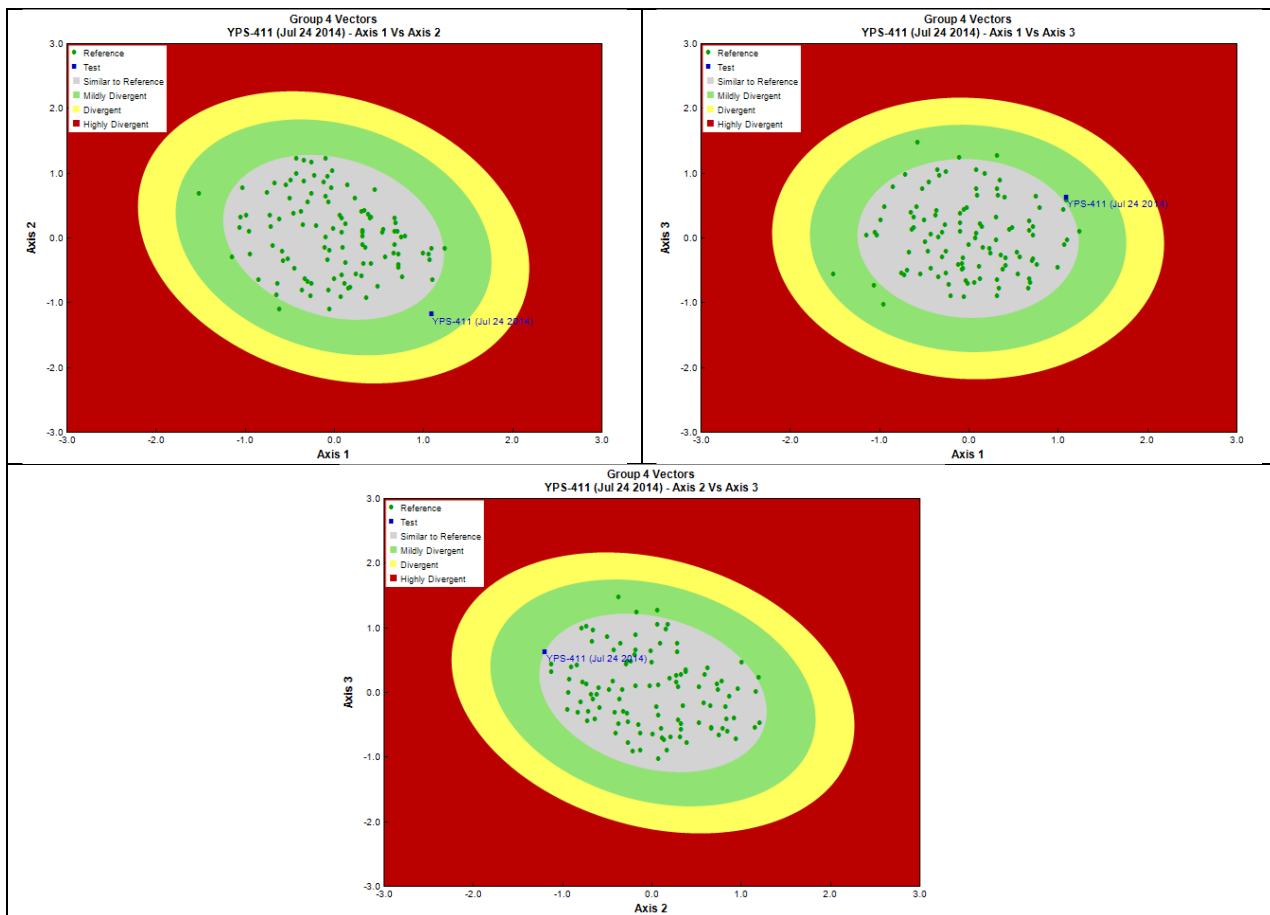
This figure displays three site assessment graphs which show the site relative to the group of reference sites to which it is compared. The three axes (or vectors) represent three dimensional space, and the probability bands (from center) are 75 - 90% (Similar to Reference), 90 – 99% (Mildly Divergent from Reference), 99 – 99.9% (Divergent from Reference), and outside 99.9% (Highly Divergent from Reference).

Vector 1 vs Vector 2	Mildly Divergent from Reference Condition
Vector 1 vs Vector 3	Mildly Divergent from Reference Condition
Vector 2 vs Vector 3	Similar to Reference
Overall	Mildly Divergent from Reference Condition

Using CABIN, YPS-411 is assessed as Mildly Divergent from Reference Condition.
