# Site Assessment Report 2014 – YPS-412

Site	YPS-412
Sample Date	Jul 24 2014
Latitude	62.34988 N
Longitude	137.27151 W
Altitude	2211
Feature Name	Big Creek
Stream Order	4

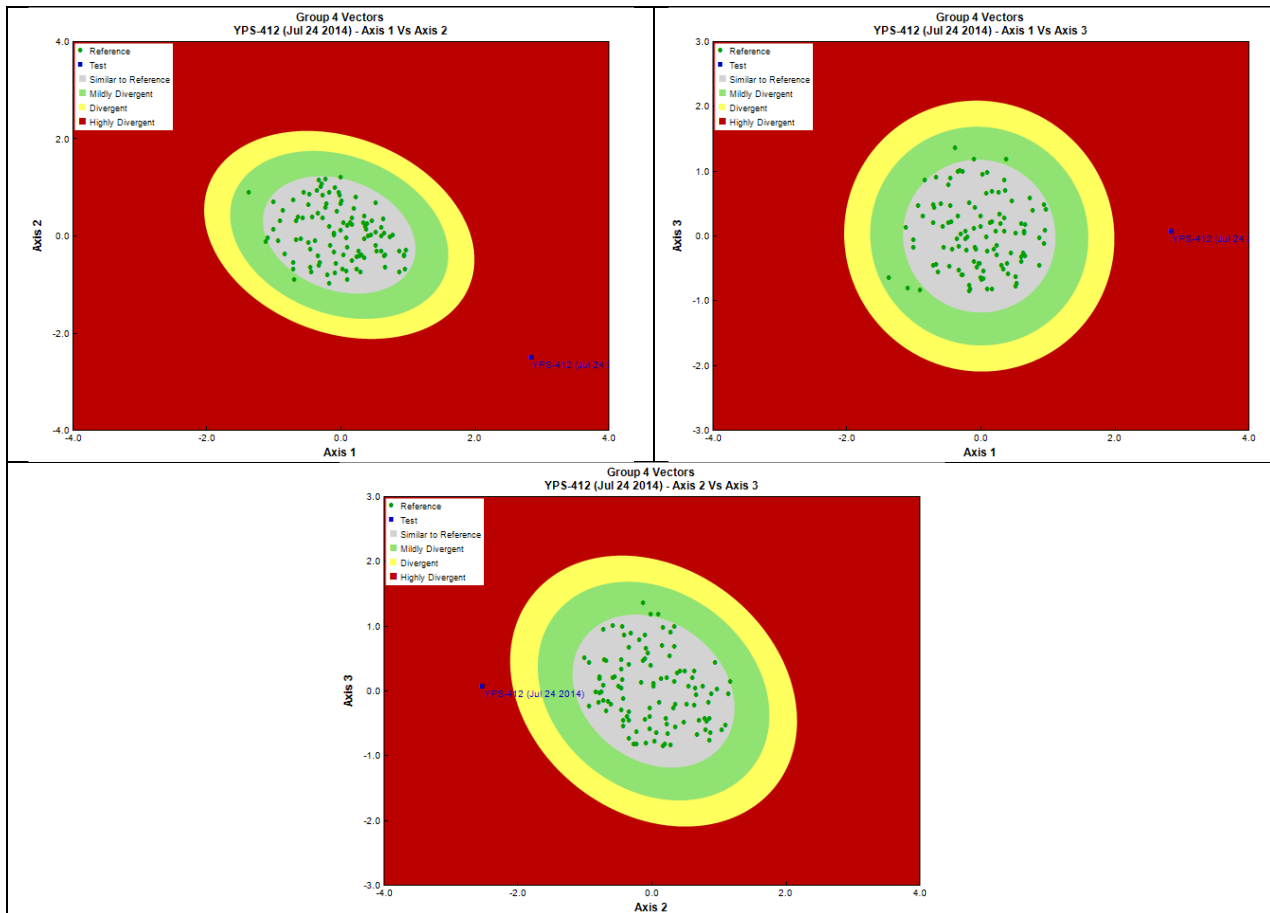
This figure displays three site assessment graphs which show the site relative to the group of reference sites to which it is compared. The three axes (or vectors) represent three dimensional space, and the probability bands (from center) are 75 - 90% (Similar to Reference), 90 – 99% (Mildly Divergent from Reference), 99 – 99.9% (Divergent from Reference), and outside 99.9% (Highly Divergent from Reference).

Vector 1 vs Vector 2	Highly Divergent from Reference Condition
Vector 1 vs Vector 3	Highly Divergent from Reference Condition
Vector 2 vs Vector 3	Highly Divergent from Reference Condition
Overall	Highly Divergent from Reference Condition

Using CABIN, YPS-412 is assessed as Highly Divergent from Reference Condition.
