Site Assessment Report 2014 – YPS-413

Site Data

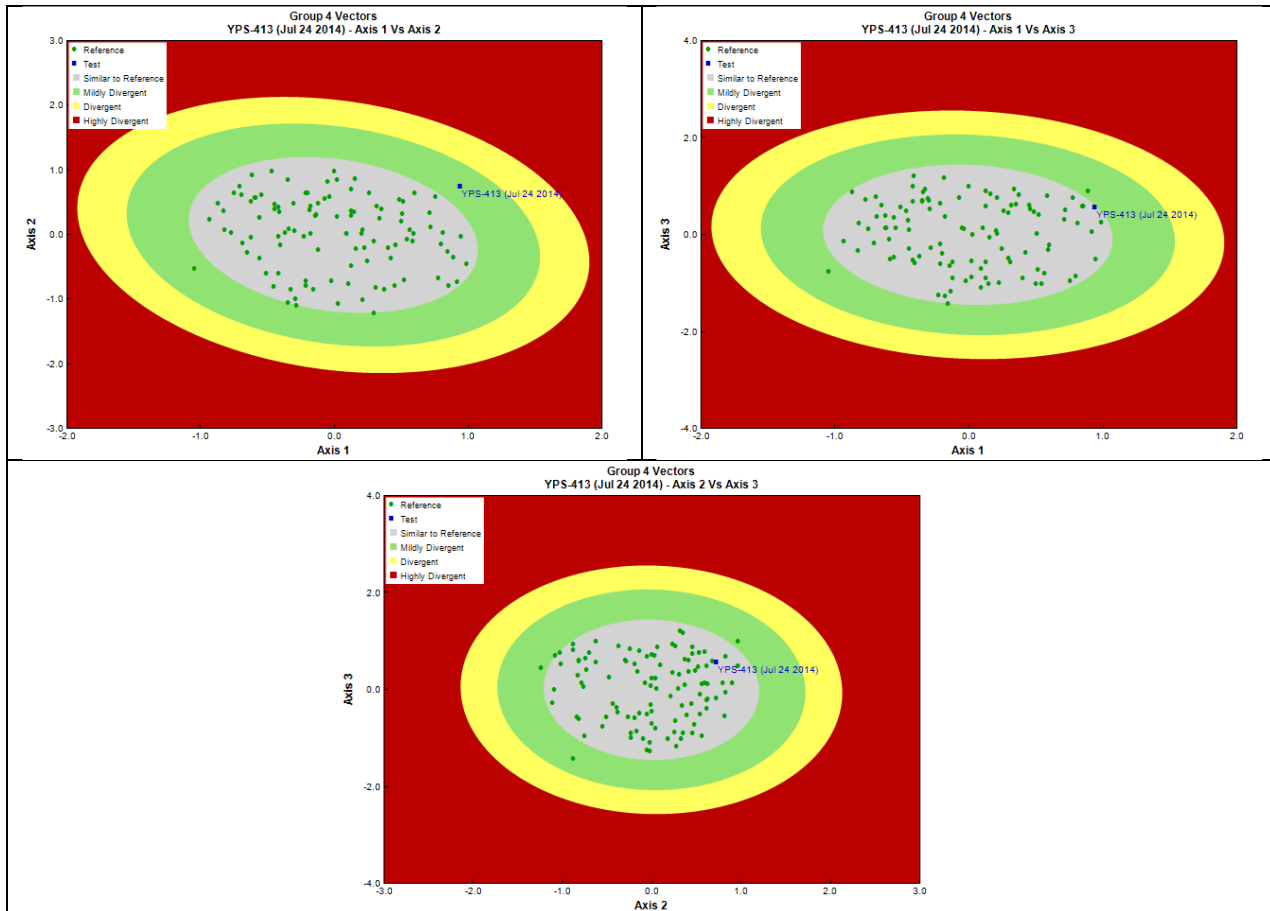
This figure displays three site assessment graphs which show the site relative to the group of reference sites to which it is compared. The three axes (or vectors) represent three dimensional space, and the probability bands (from center) are 75 - 90% (Similar to Reference), 90 – 99% (Mildly Divergent from Reference), 99 – 99.9% (Divergent from Reference), and outside 99.9% (Highly Divergent from Reference).

Vector 1 vs Vector 2	Mildly Divergent from Reference Condition
Vector 1 vs Vector 3	Similar to Reference
Vector 2 vs Vector 3	Similar to Reference
Overall	Mildly Divergent from Reference Condition

Using CABIN, YPS-413 is assessed as in Mildly Divergent from Reference Condition.
