Site Assessment Report 2014 – YPS-427

Site	YPS-427
Sample Date	Jul 23, 2014
Latitude	63.27806 N
Longitude	-134.41361 W
Altitude	1308
Feature Name	Rosebud Creek
Stream Order	5

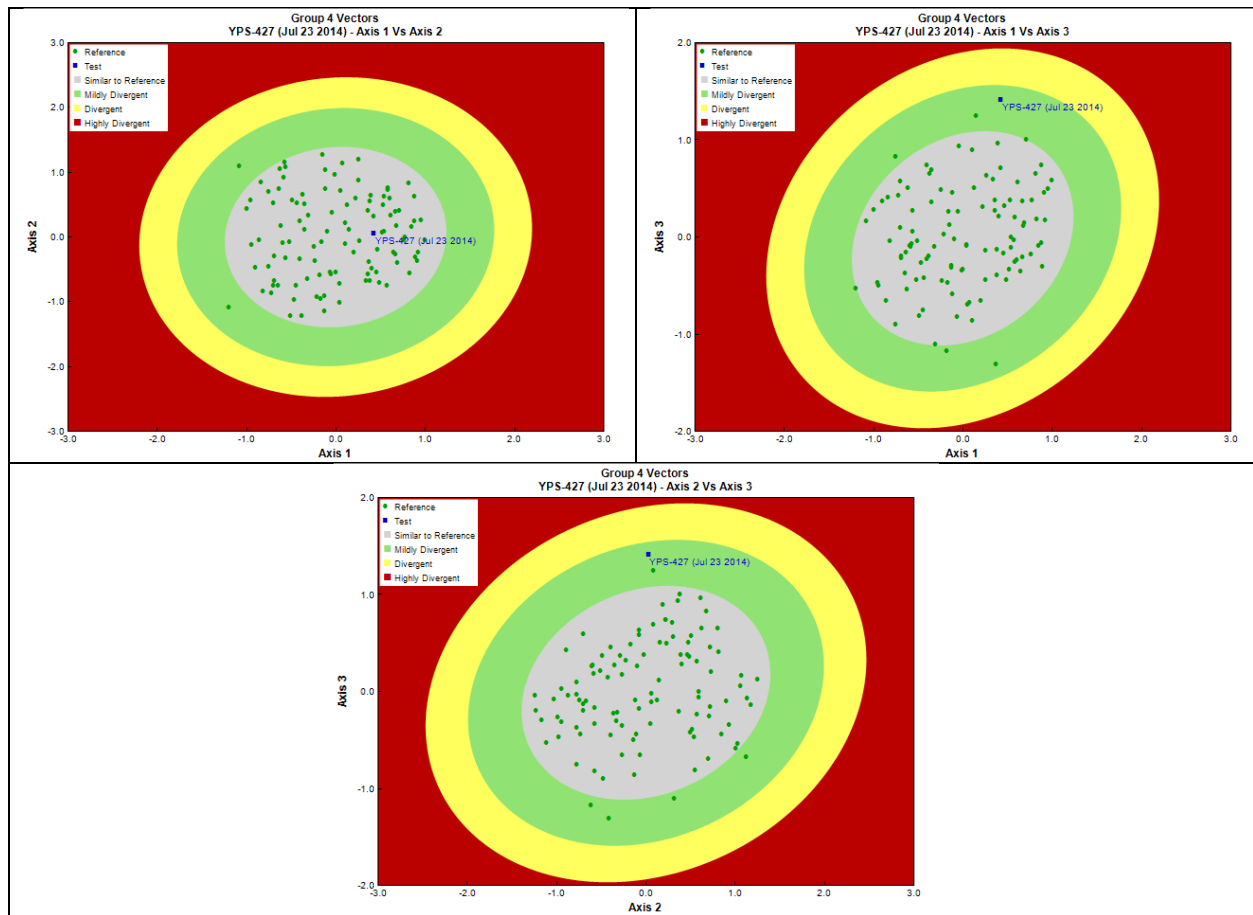
This figure displays three site assessment graphs which show the site relative to the group of reference sites to which it is compared. The three axes (or vectors) represent three dimensional space, and the probability bands (from center) are 75 - 90% (Similar to Reference), 90 – 99% (Mildly Divergent from Reference), 99 – 99.9% (Divergent from Reference), and outside 99.9% (Highly Divergent from Reference).

Vector 1 vs Vector 2	Similar to Reference
Vector 1 vs Vector 3	Mildly Divergent from Reference Condition
Vector 2 vs Vector 3	Mildly Divergent from Reference Condition
Overall	Mildly Divergent from Reference Condition

Using CABIN, YPS-427 is assessed as Mildly Divergent from Reference Condition.
