Site Assessment Report 2014 - YPS-428

Site	YPS-428
Sample Date	Jul 23, 2014
Latitude	63.255 N
Longitude	138.69 W
Altitude	1248
Feature Name	Black Hills Creek
Stream Order	4

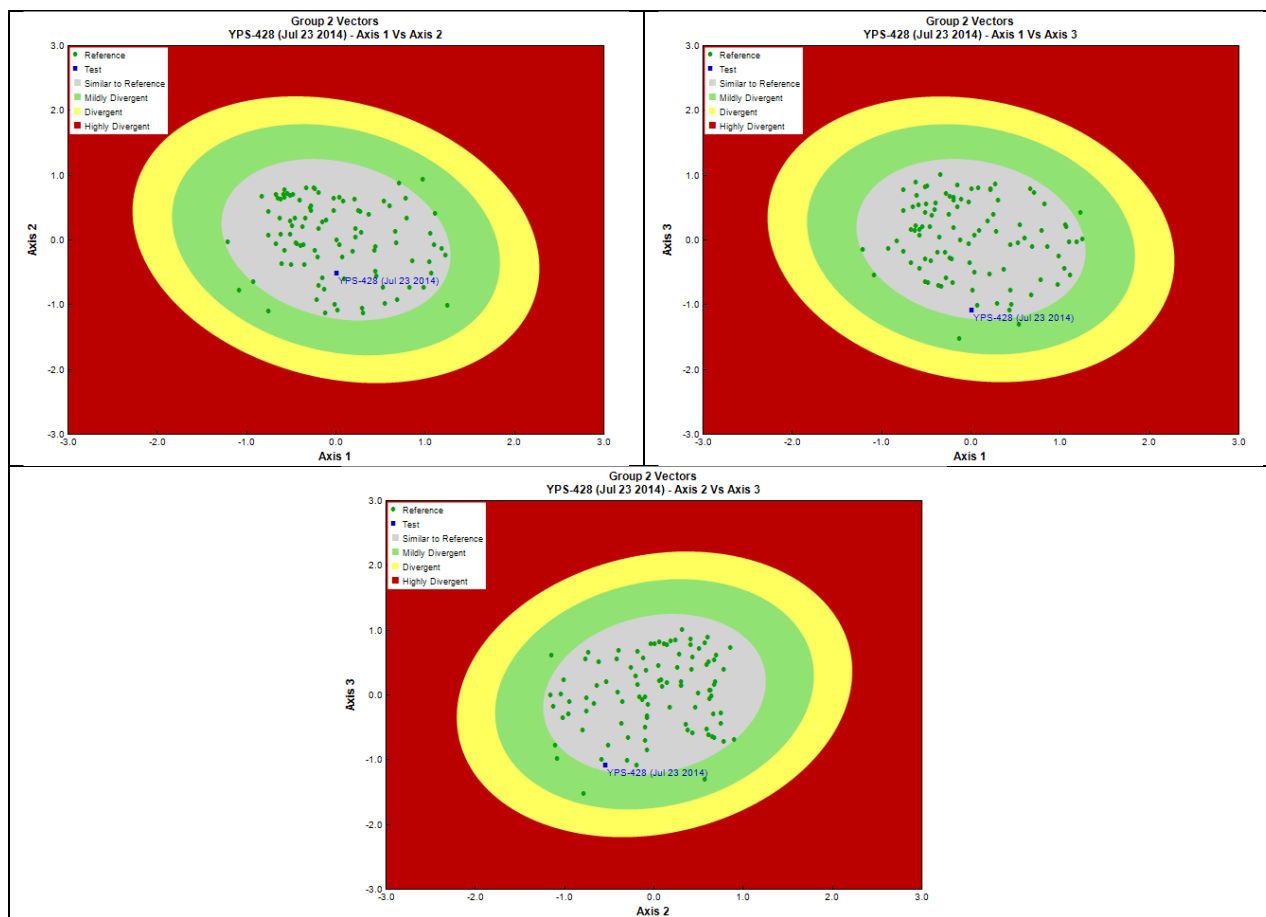
Visual Reports on Site Condition

This figure displays three site assessment graphs which show the site relative to the group of reference sites to which it is compared. The three axes (or vectors) represent three dimensional space, and the probability bands (from center) are 75 - 90% (Similar to Reference), 90 – 99% (Mildly Divergent from Reference), 99 – 99.9% (Divergent from Reference), and outside 99.9% (Highly Divergent from Reference).

Vector 1 vs Vector 2	Similar to Reference
Vector 1 vs Vector 3	Similar to Reference
Vector 2 vs Vector 3	Similar to Reference
Overall	Similar to Reference

Using CABIN, YPS-428 is assessed as Similar to Reference.
