2012 ANNUAL WATER LICENCE REPORT

Water Use License QZ96-006

2012 ANNUAL QUARTZ MINING LICENCE REPORT

Minto Mine

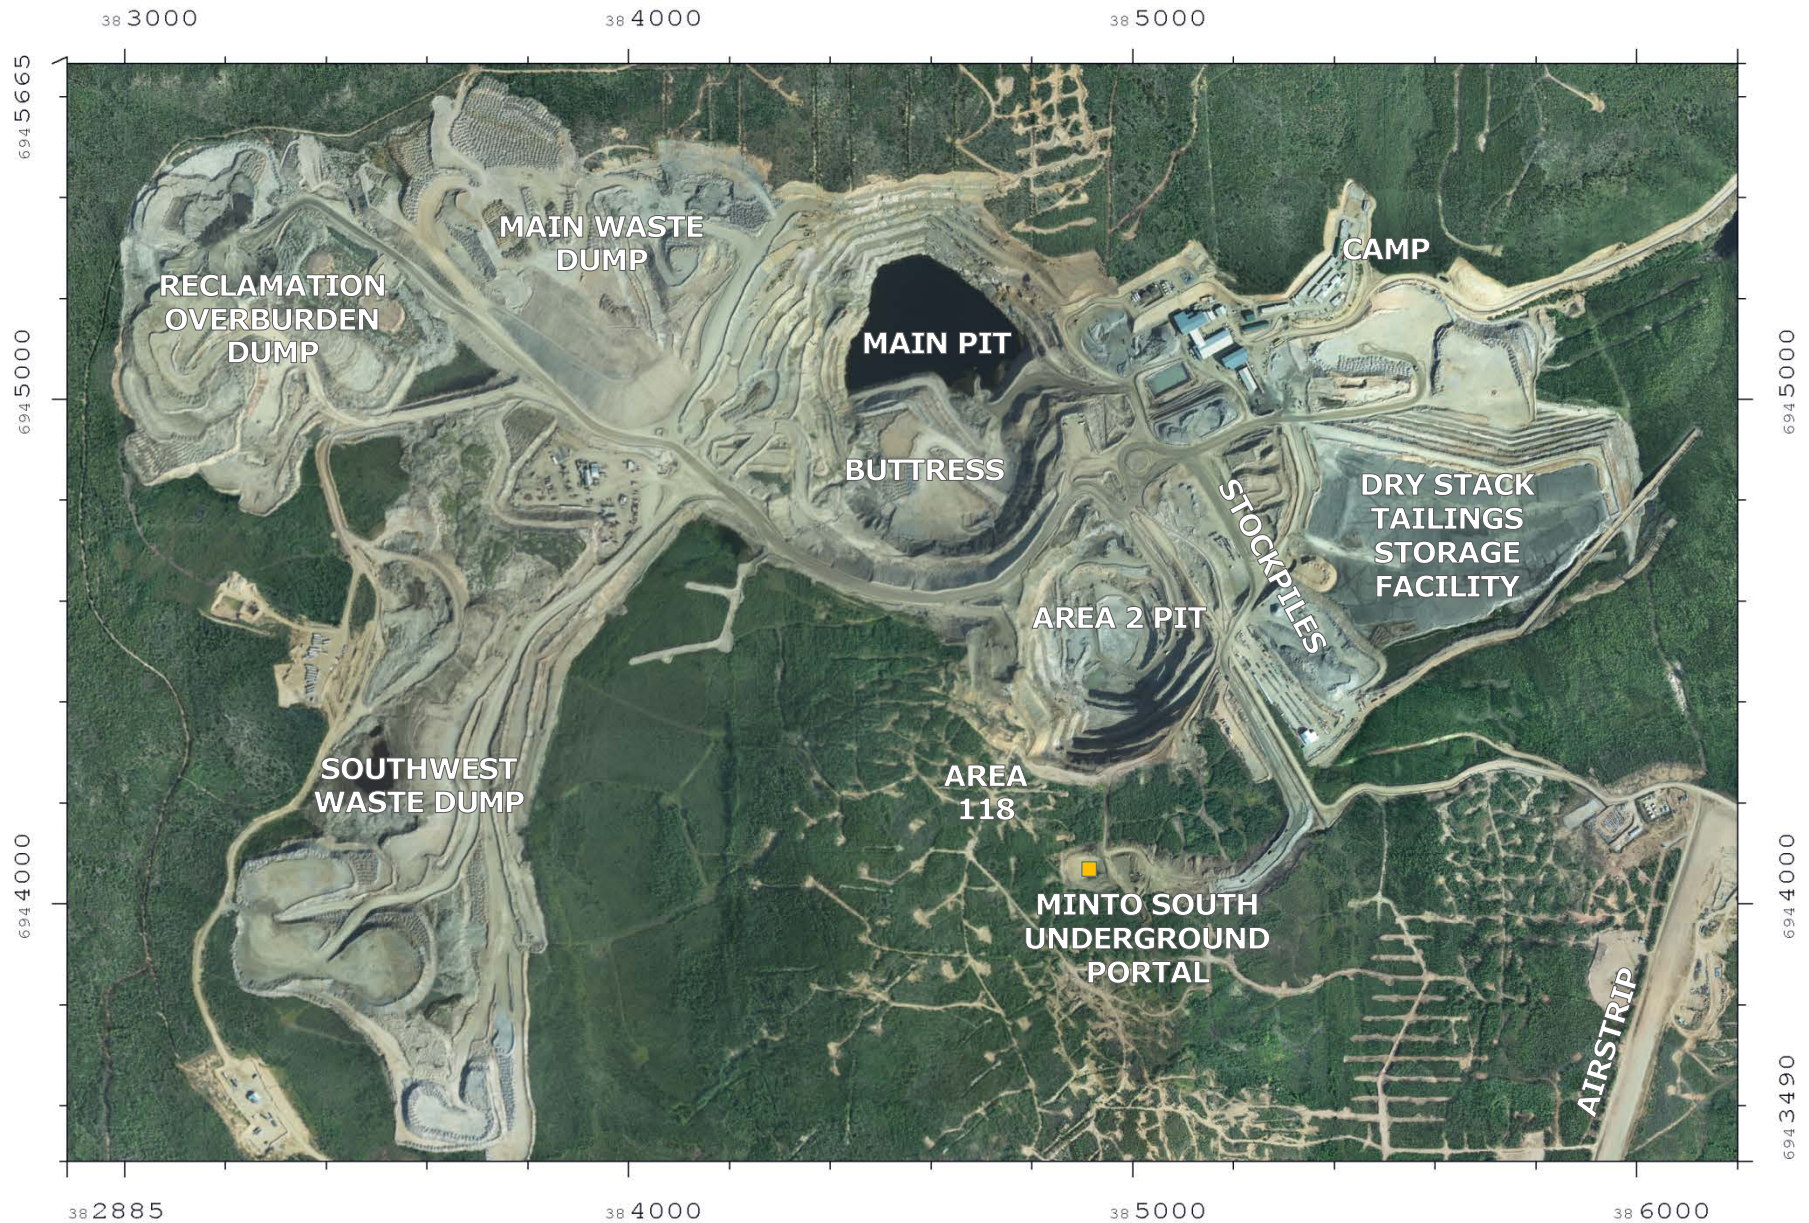
Figure 1-1: Site overview as of August 2012 (scale: 1:10000).

An aerial photo taken in August 2012 with site infrastructure labeled is presented in Figure 1-1, and site conditions at the end of the reporting period are presented in Figure 1-2,

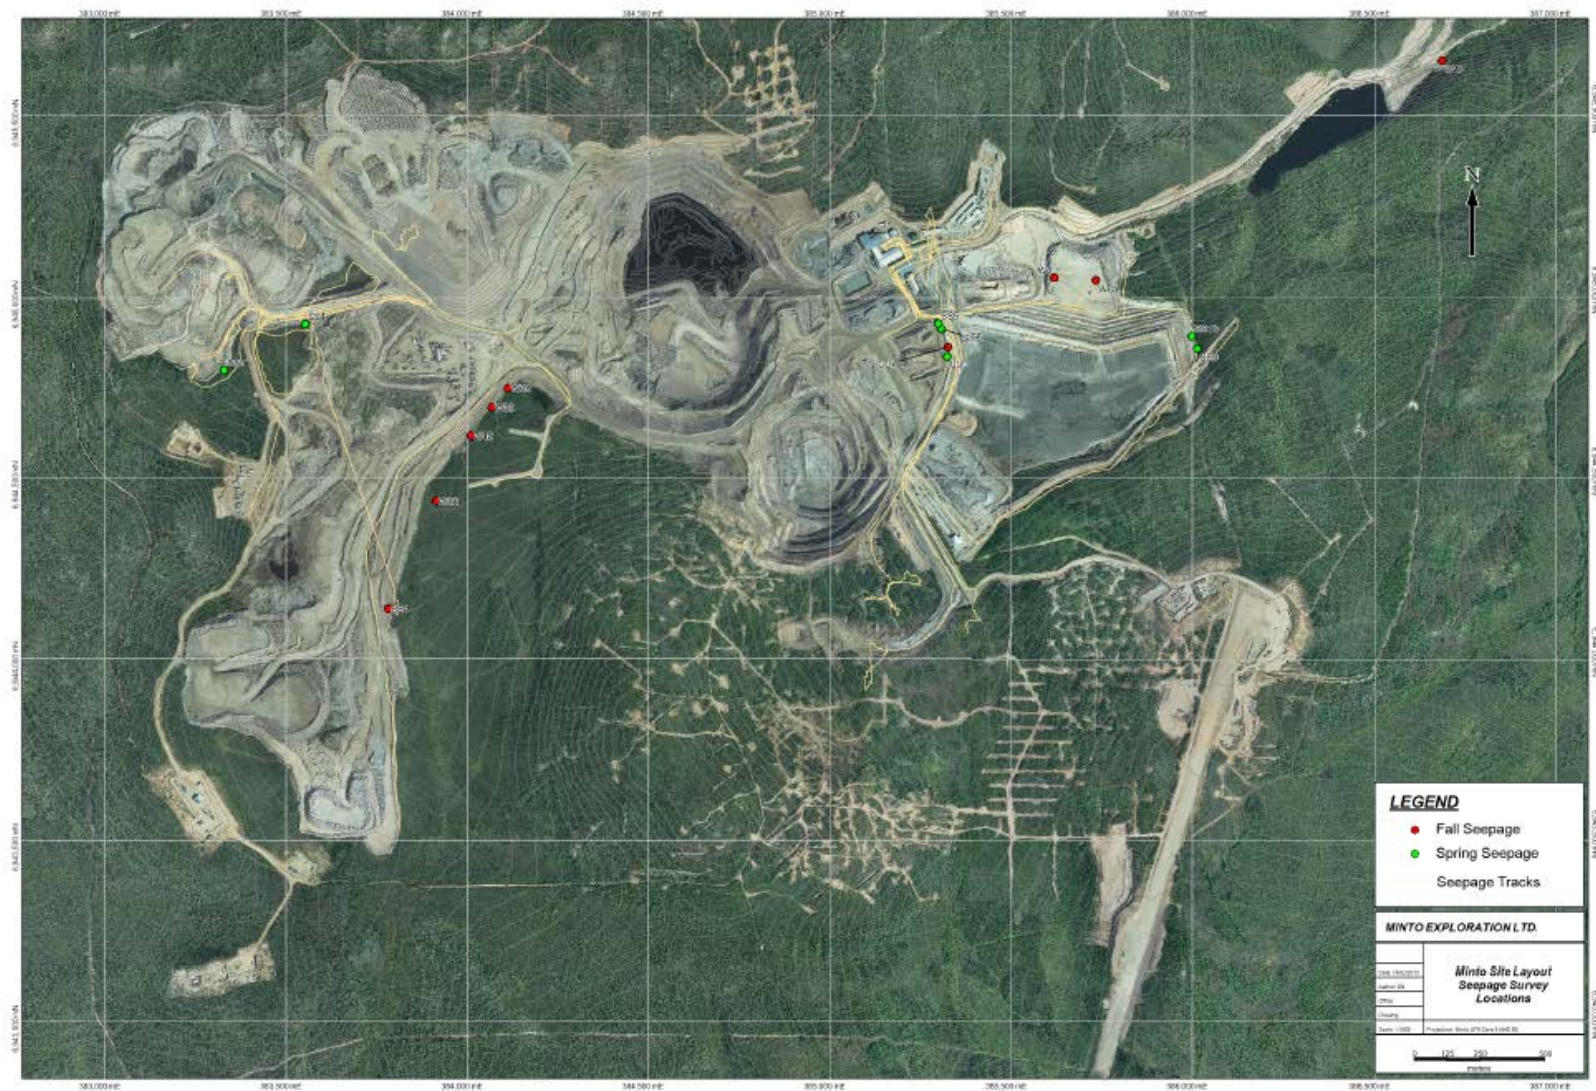
Figure 5-13: 2012 Minto Mine overview with seepage surveys (in yellow) and sample locations (fall samples in red and spring samples in green).

The *Seepage Monitoring Plan* states that seepage surveys will be conducted twice a year, during spring runoff and in early fall, by walking the toe of each waste dump, stockpile or other area of interest; for each seepage monitoring event survey routes will be recorded using the tracking function of a Global Positioning System (GPS). Figure 5-13 displays the 2012 survey routes and monitoring locations.

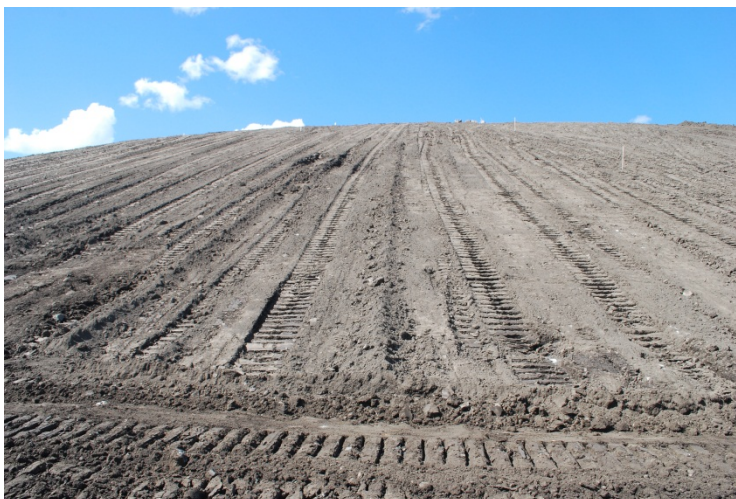
Figure 8-5: Plot surface after grading with the D6 Cat dozer.

The seeding surface was prepared by lightly grading the surface with the blade of a CAT D-6 dozer. The light grading was key for the slopes that had overburden placed on them in 2011, this grading brought moisture to the surface and broke up the hard surface created by heavy snow pack over the winter of 2011/2012 (Figure 8-5). The dozer tracks running up and down the plot's surface, perpendicular to the slope, created microsites. These microbenches are capable of capturing moisture, seeds and fertilizer pellets in depressions (Figure 8-6).

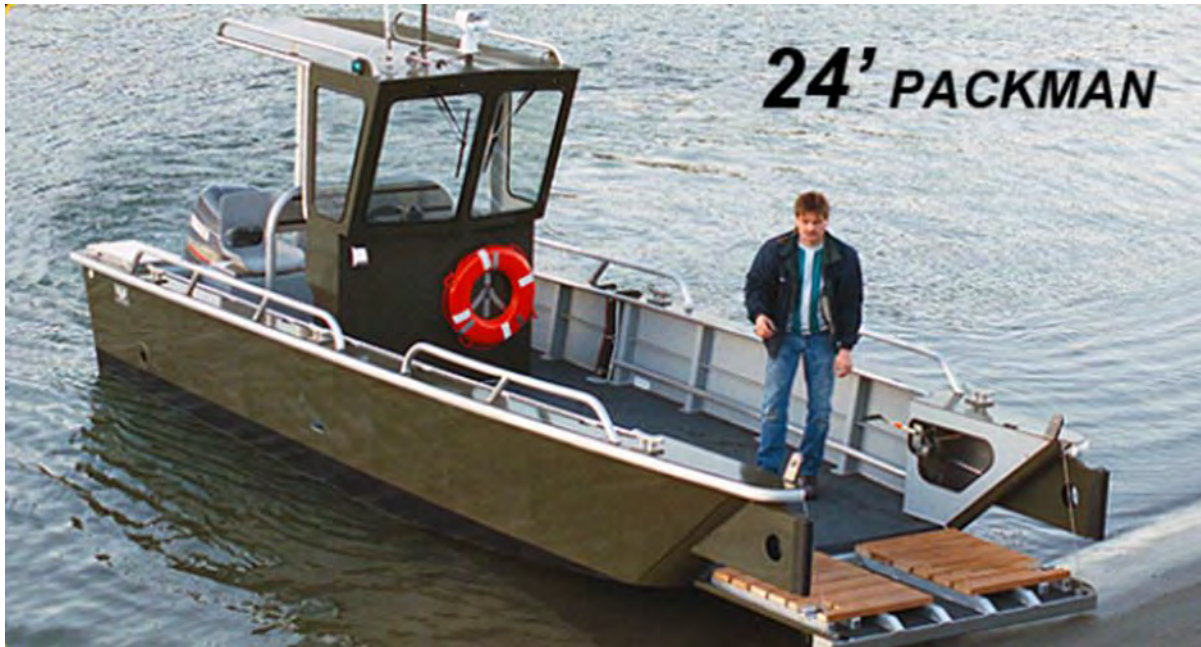
Appendix A
Man Boat Specifications

- Brand/Model: Munson Packman Landing Craft
- Hull Length: 24 feet (7.3 meters)
- Beam: 8 feet 6 inches (2.6 meters)
- Hull Type: Packman mono hull
- Power: Twin Yamaha 150hp
- Propulsion: Outboard (25" shaft)
- Outfitting: 52" bow door
